FEASIBILITY REPORT

2026 MISCELLANEOUS IMPROVEMENTS PROJECT

CITY PROJECT NO. 26-01

WSB PROJECT NO. 031254-000

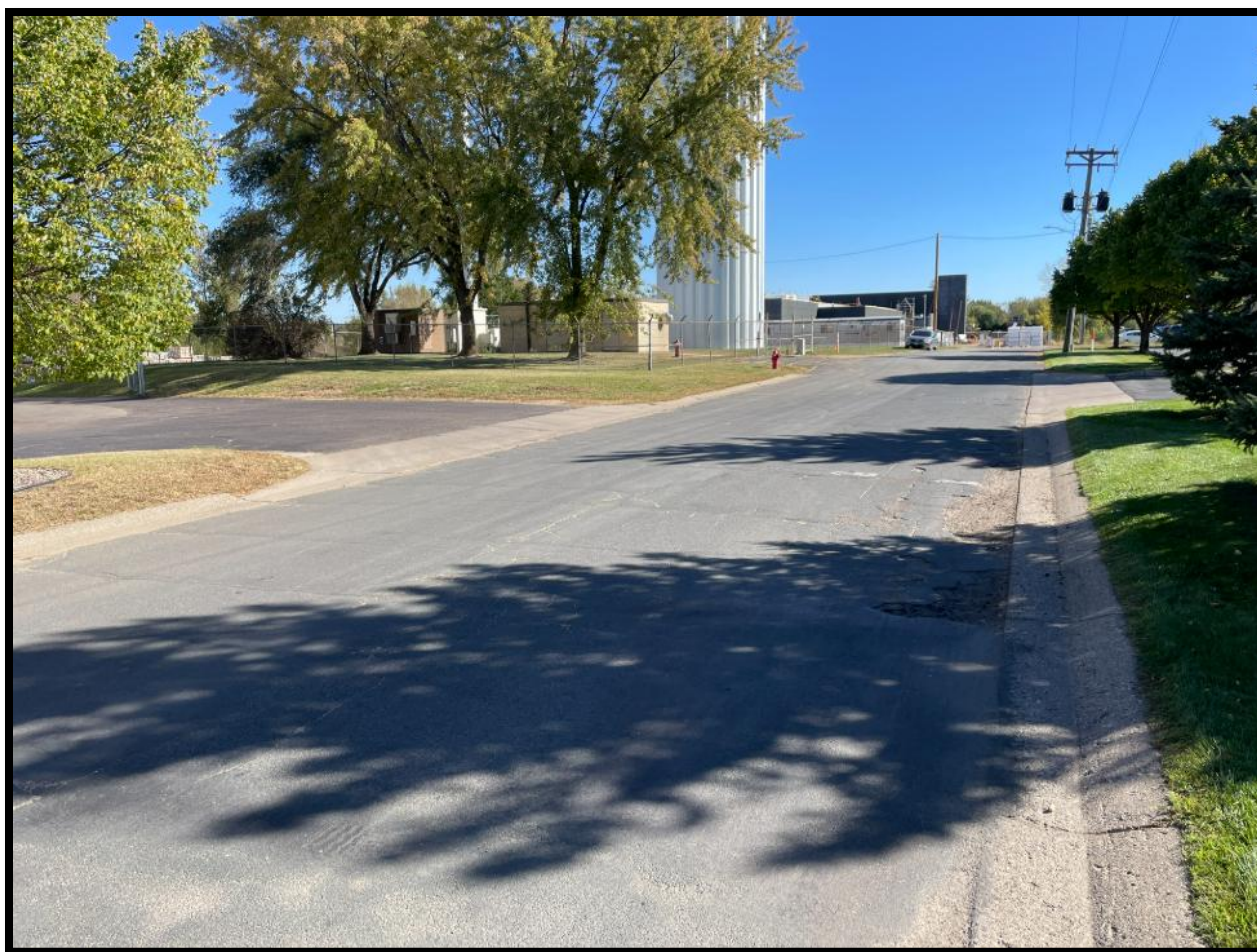
The photos below illustrate some of the varying levels of pavement distress:

Photo 1. 214th Street West looking east.

214th Street West is aging and displays varying severities of wear and distress, including alligator, transverse, and longitudinal cracking. The western portion of 214th Street West is urbanized with surmountable concrete curb and gutter; however the eastern portion is a rural street section because it does not include curb. The curb and gutter condition is poor overall, with isolated instances of cracking, heaving, and settlements that may contribute to localized draining issues.

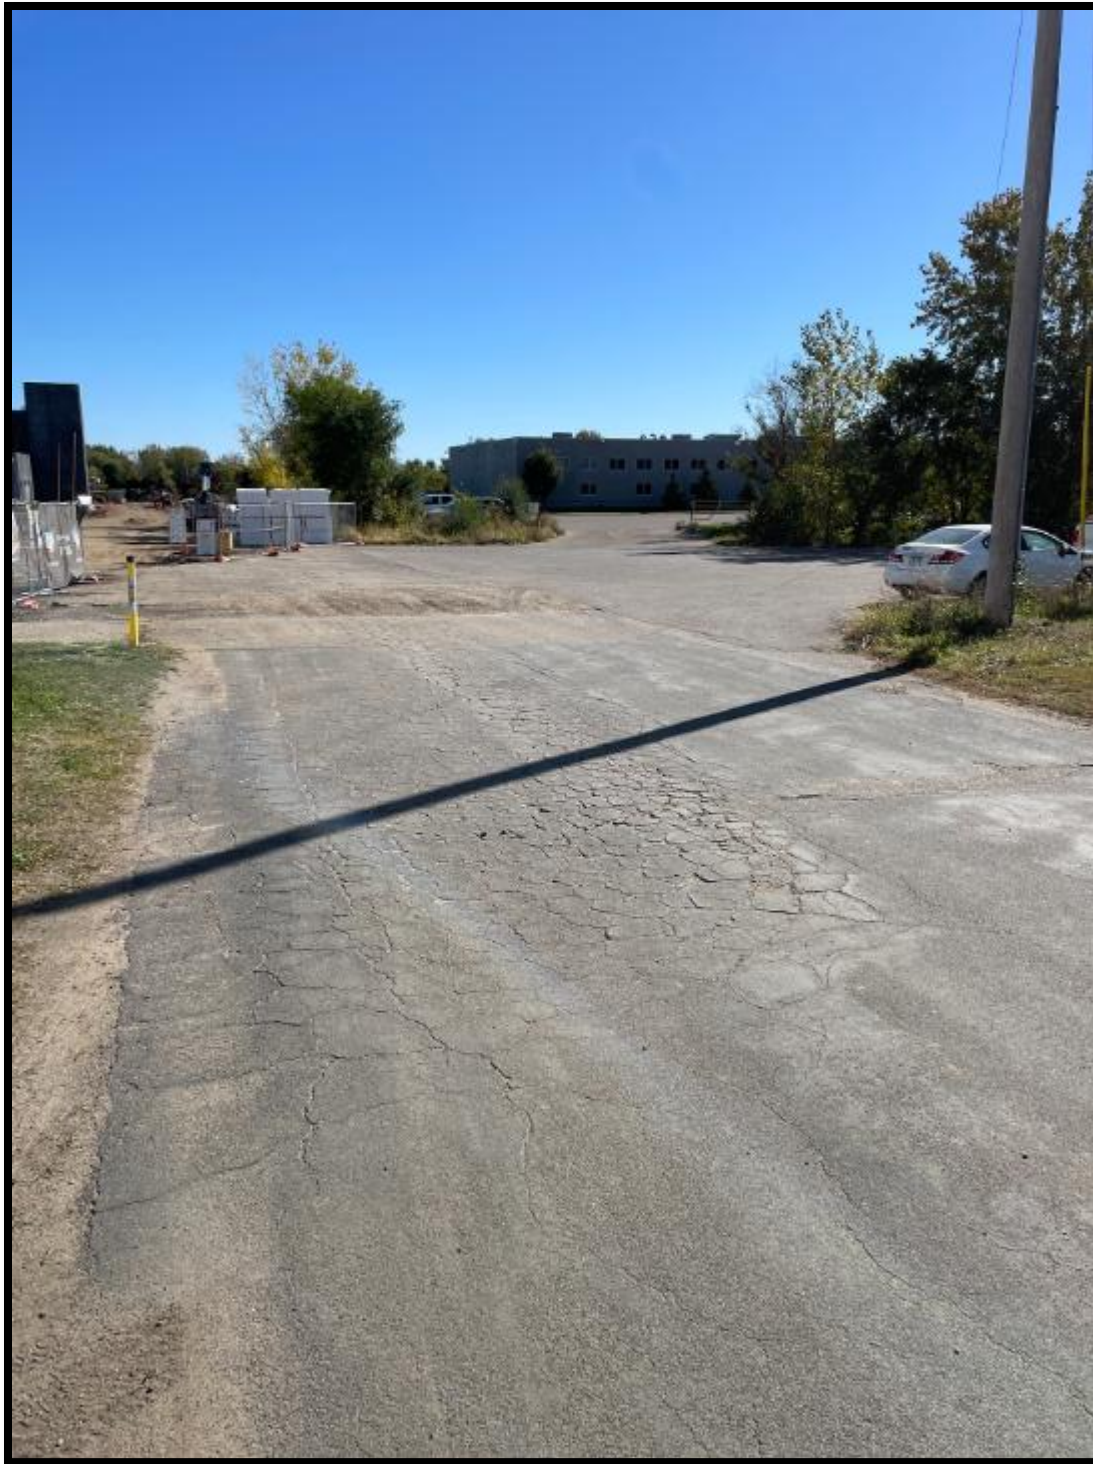
Photo 2. 214th Street West looking east towards the cul de sac.

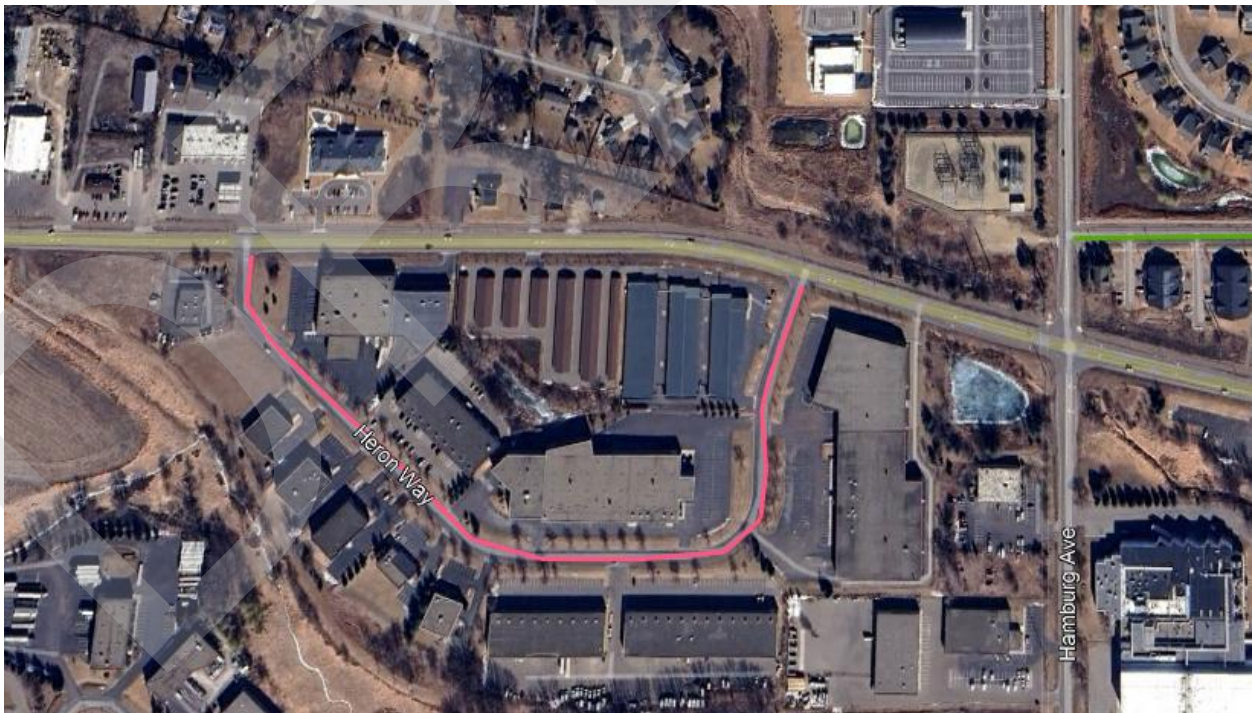
Figure 1-2. Existing roadway layout showing Heron Way (pink)

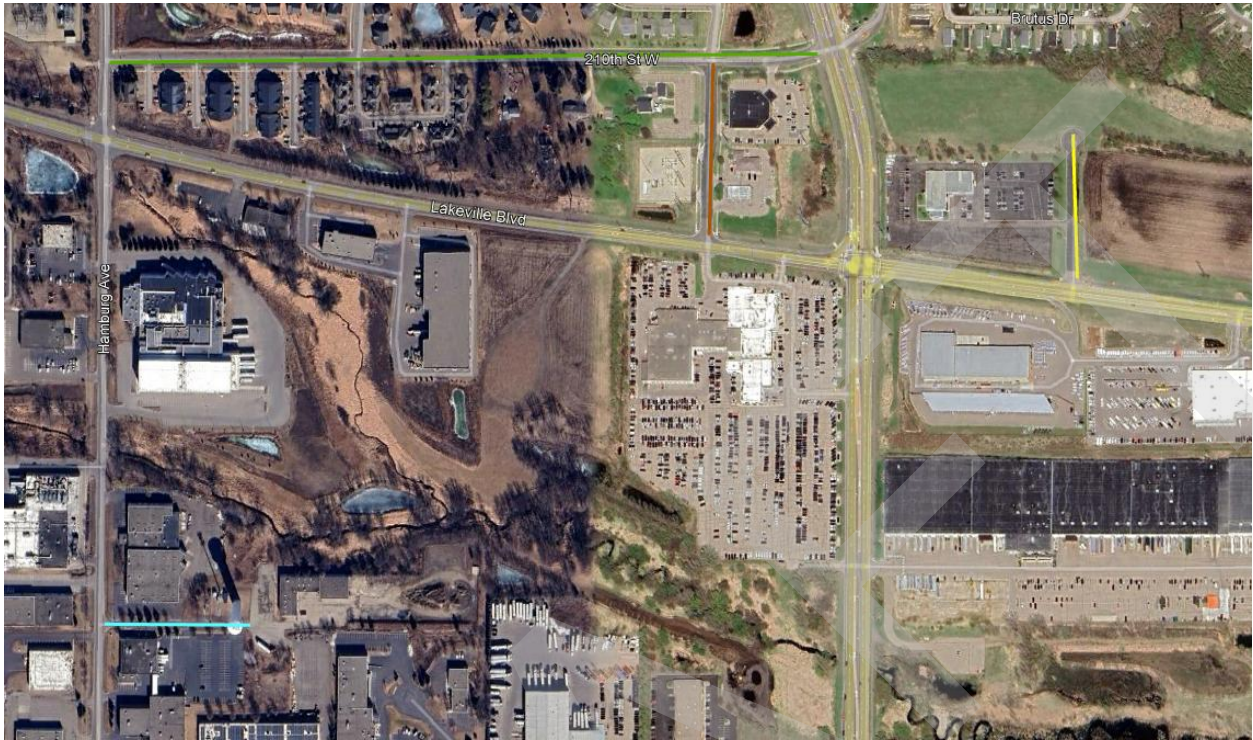
Figure 1-3. Existing roadway layout showing 214th Street West (light blue), 210th Street West (green), Glade Avenue (brown), and Gateway Drive (yellow).

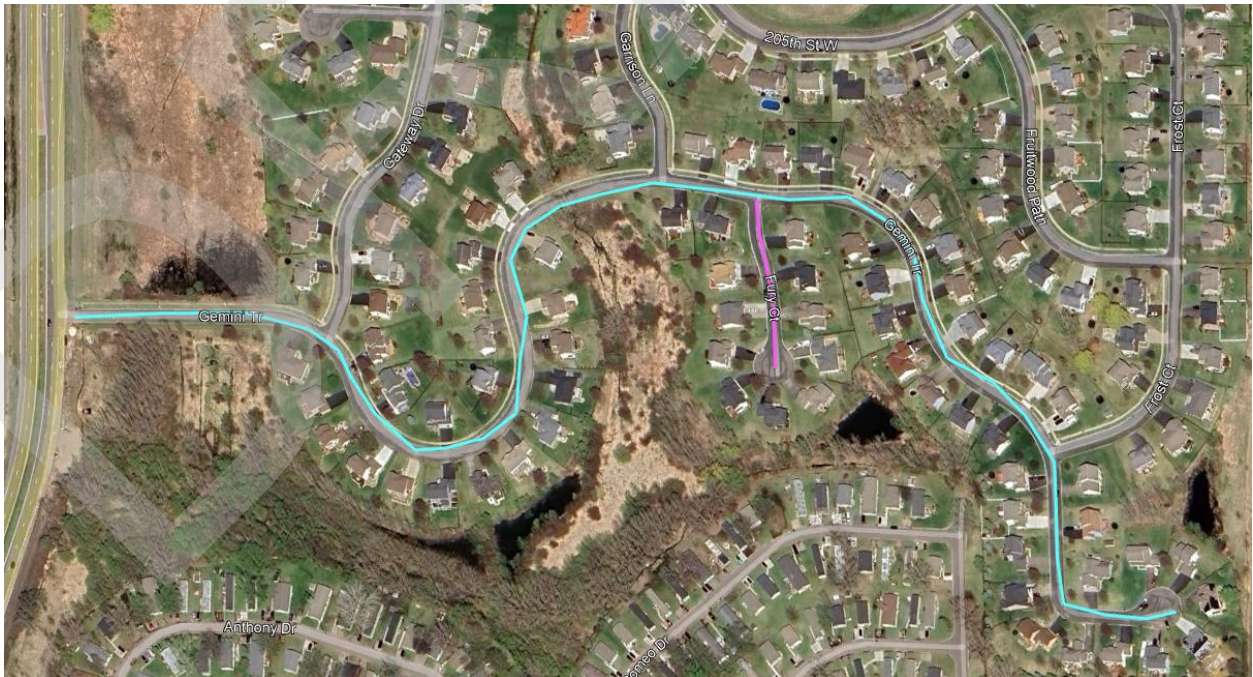
Figure 1-4. Existing roadway layout showing Gemini Trail (light blue) and Fury Court (purple).

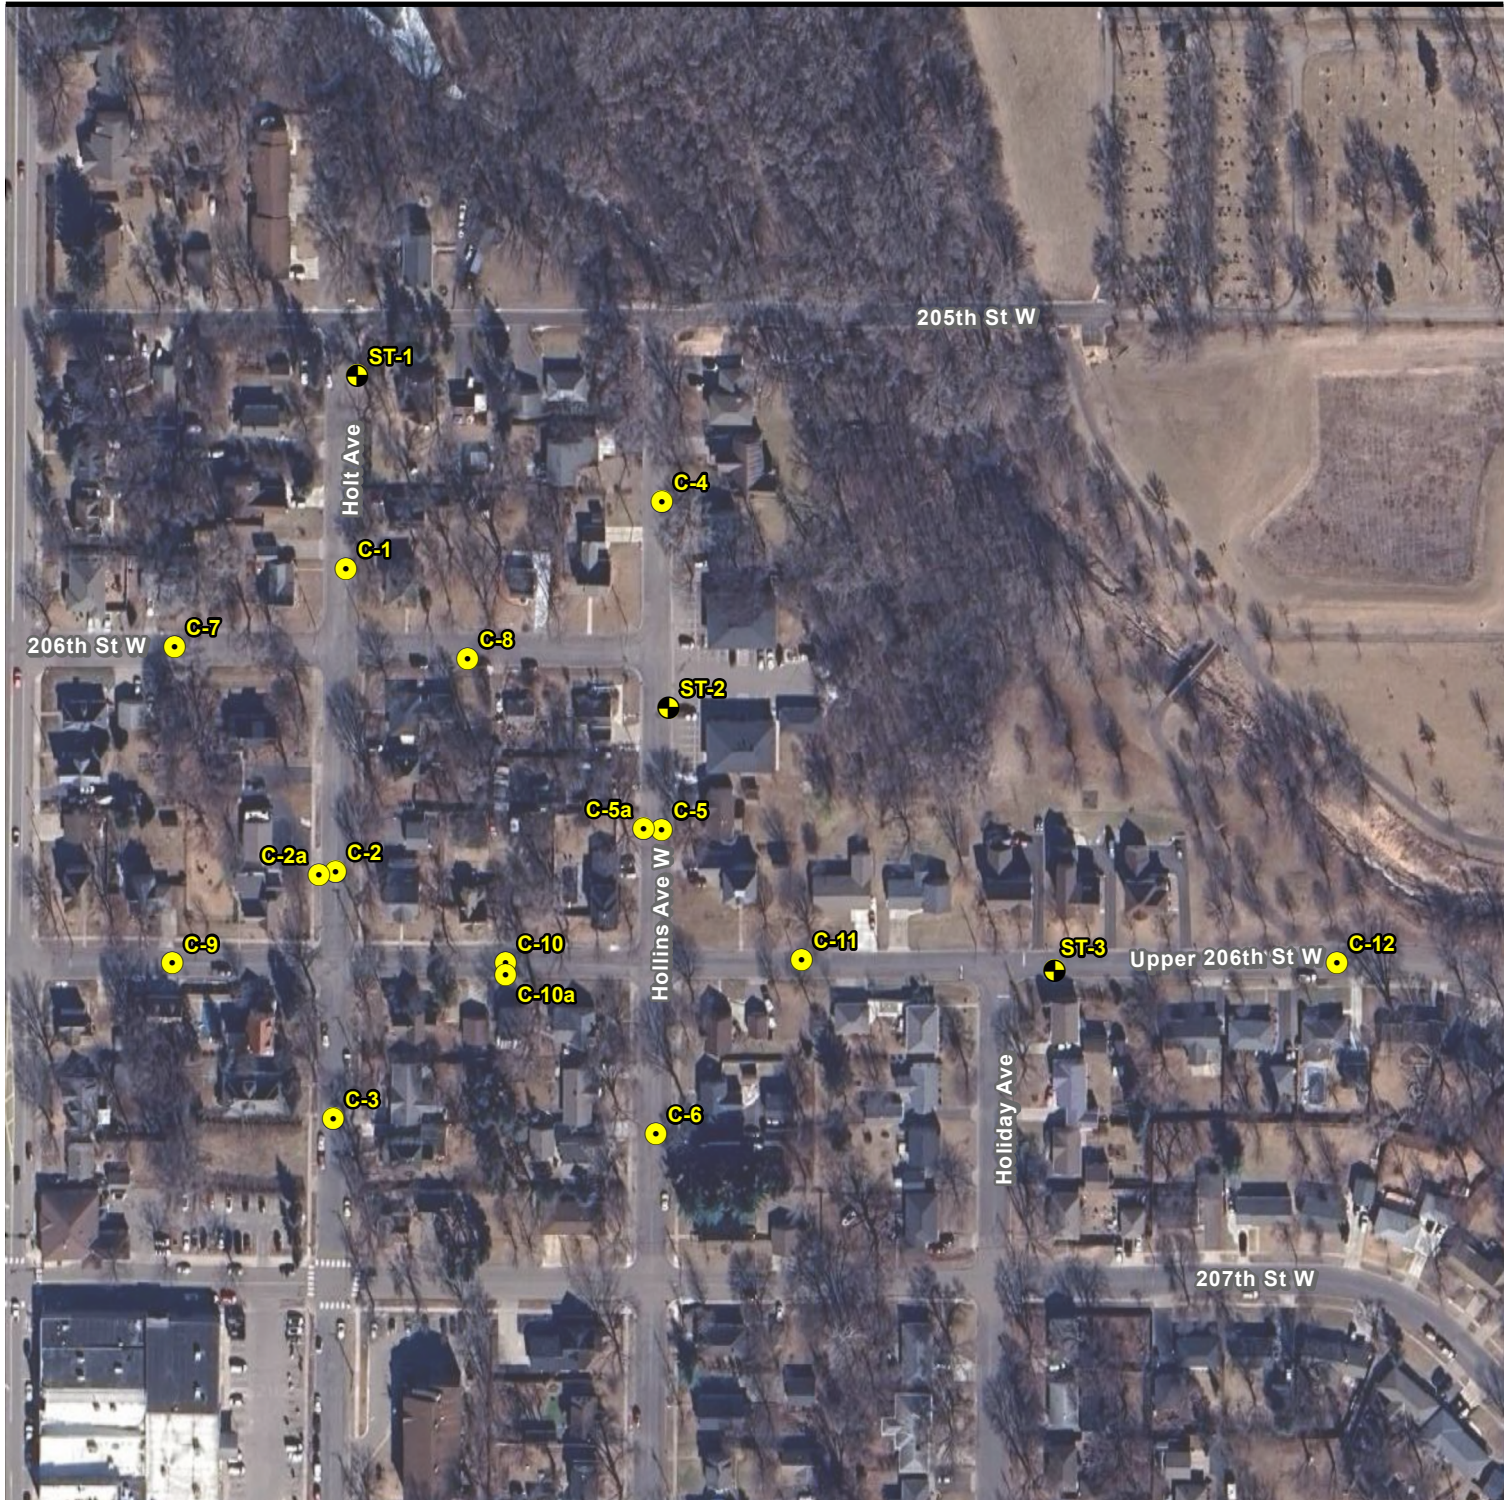
- Coring Location
- Boring Location

Soil borings and corings for streets within the 2026 project area were collected in August of 2025 by Braun Intertec. Ground penetrating radar (GPR) was employed in both directions on the street to collect interpretations on pavement layer thickness between boring and coring locations. The draft geotechnical report is included in **Appendix C**, and the draft boring and coring logs were used to determine the feasibility of a full depth pavement removal and replacement including subgrade correction. The final geotechnical report will be available with final design. The quantities included in the Opinion of Probable Cost, **Appendix B**, are based on the draft geotechnical report.

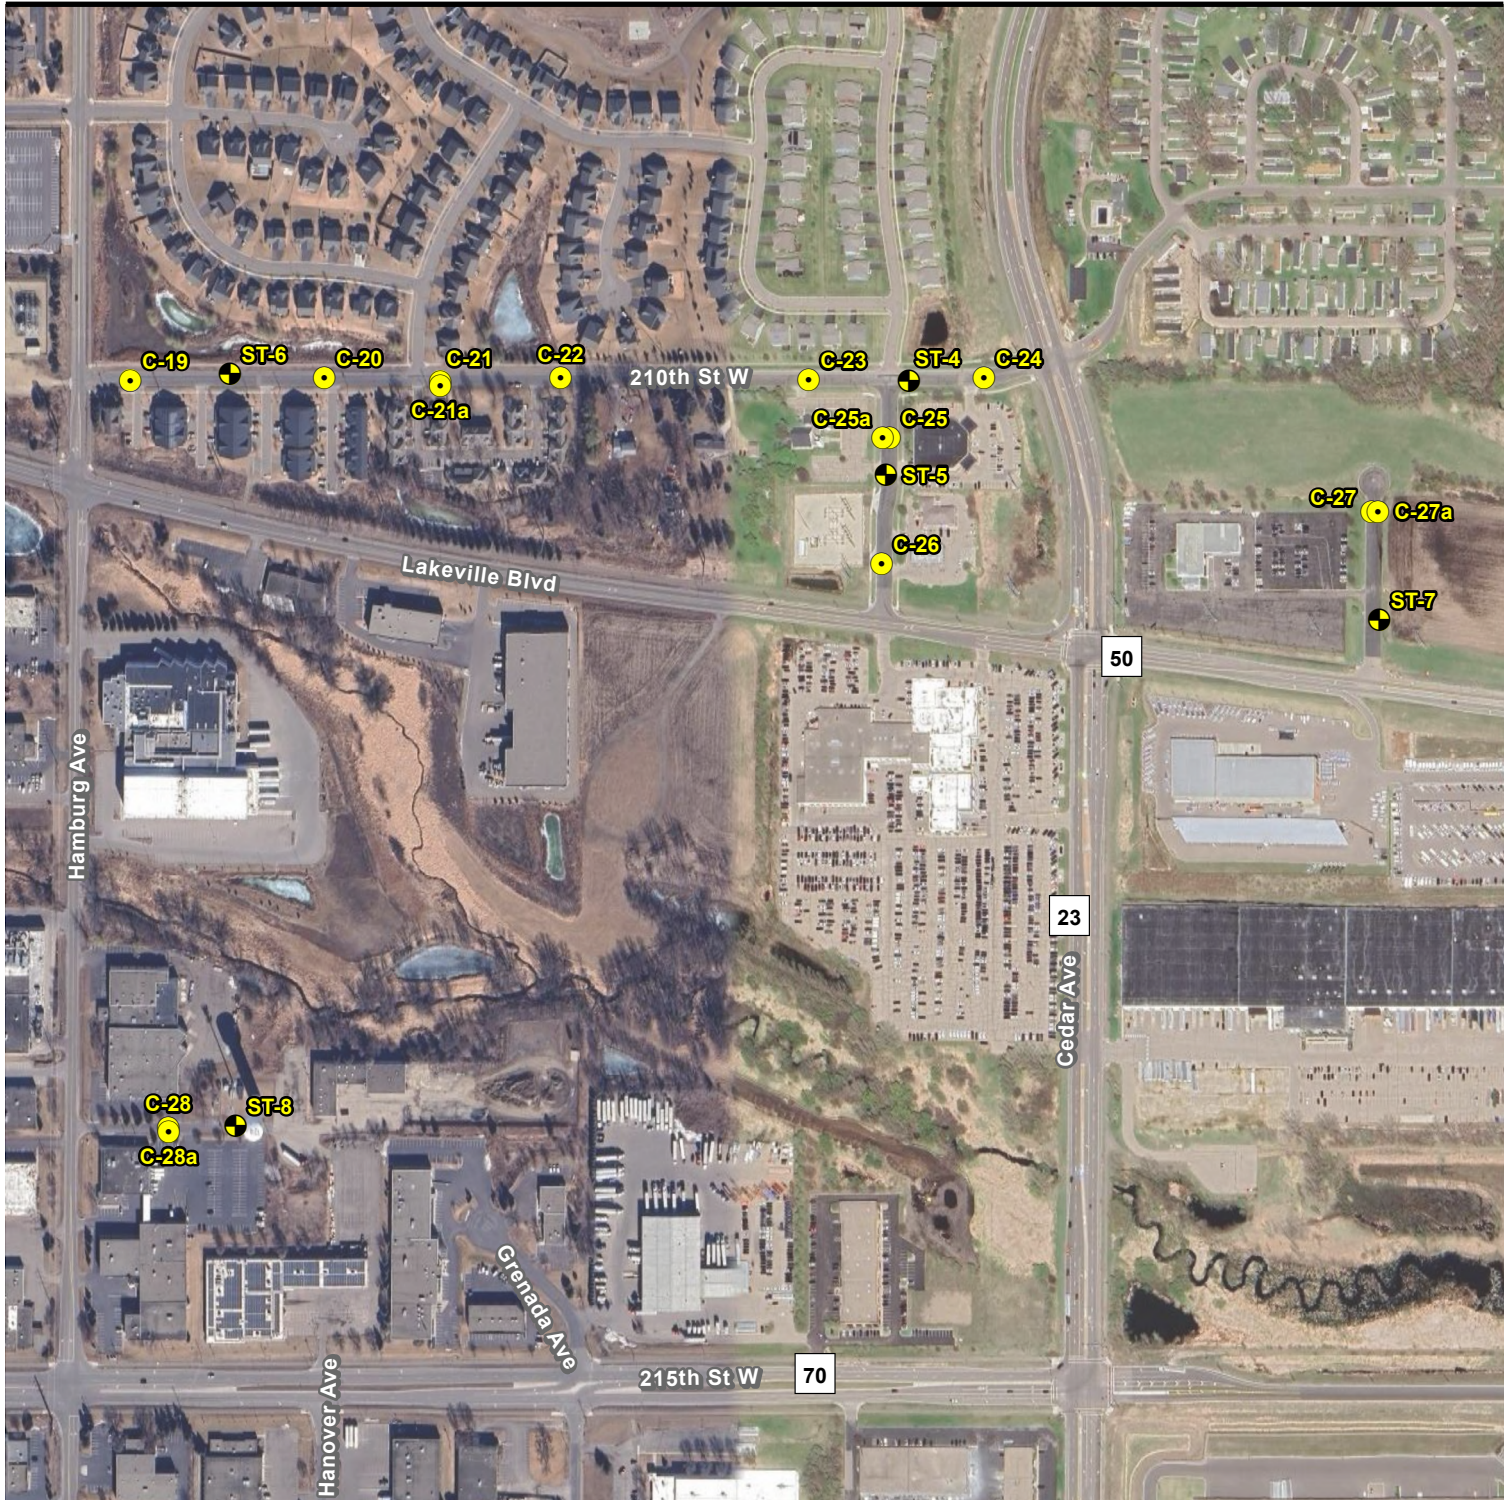
Sheet:
2 of 5

Boring and Coring
Location Sketch

- Coring Location
- ⊗ Boring Location

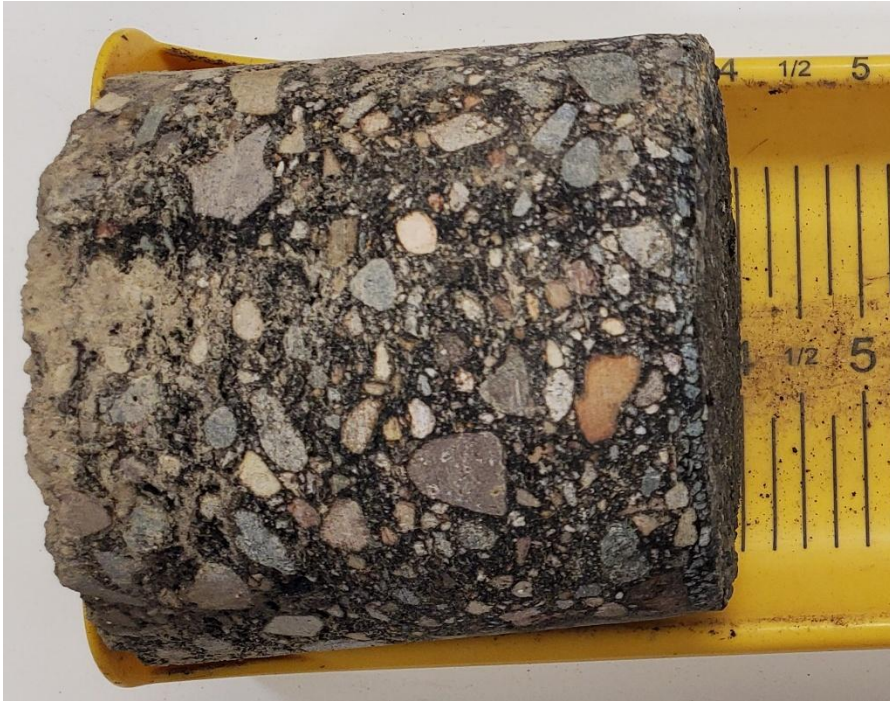
C-28
Surface

Core Number	Associated Roadway	Bituminous Thickness (inches)	Apparent Aggregate Base Thickness (inches)	Subgrade Soils	Pavement Core Conditions
C-28	214 th Street West	4	14	SC	Good condition
C-28a		4	---	---	Moderate stripping
C-29	Gemini Trail	3 1/2" bituminous over 3 1/2" rehydrated concrete	10	SP	Minor stripping
C-30**		3 1/2	10	SP	Minor surface raveling
C-31**		3 3/4	6	SP	Minor stripping
C-31a		4	---	---	Minor stripping and debonded at 1 1/2" from the surface
C-32		4 1/4" bituminous over 2" rehydrated concrete	10	SP	Good condition
C-33		3 3/4" bituminous over 4" rehydrated concrete	10	SP	Minor surface raveling
C-34		4 1/4" bituminous over 6 1/2" rehydrated concrete	10	SP	Good condition
C-34a		4 1/4	---	---	Good condition
C-35		4 1/2" bituminous over 3" rehydrated concrete	10	SP	Good condition
C-36		3 1/2" bituminous over 4 1/2" rehydrated concrete	10	SP	Good condition
C-36a	3 3/4	---	---	Good condition
