ENGINEERING REPORT

2026 STREET REHABILITATION PROJECT

November 25, 2025

CITY PROJECT NO. 26-02

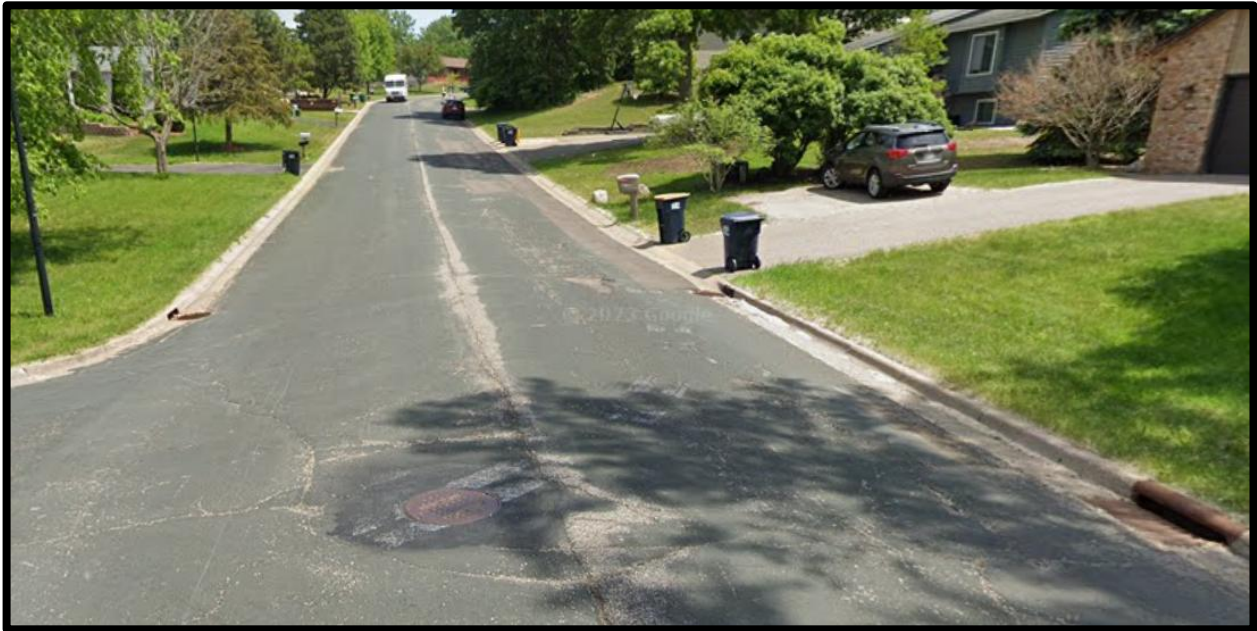
Photo 1. Jaguar Path looking northeast from Upper 178th Street West intersection.

The photos below illustrate some of the varying levels of pavement distress:

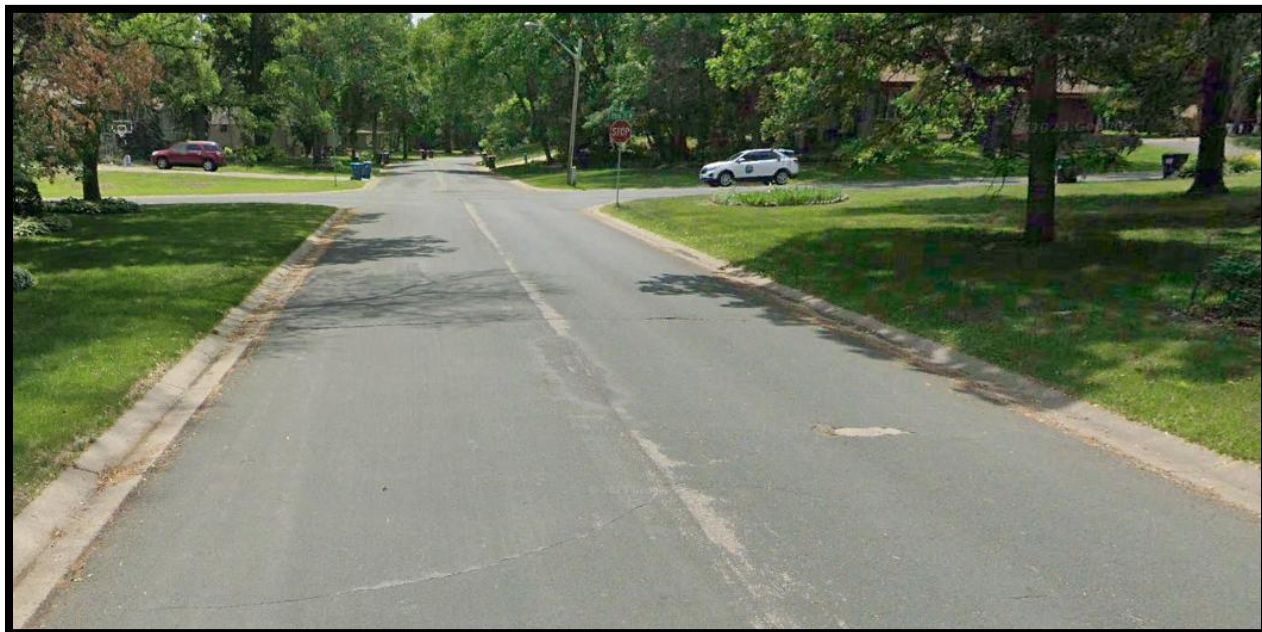
Photo 2. Ixonia Avenue looking south toward 178th

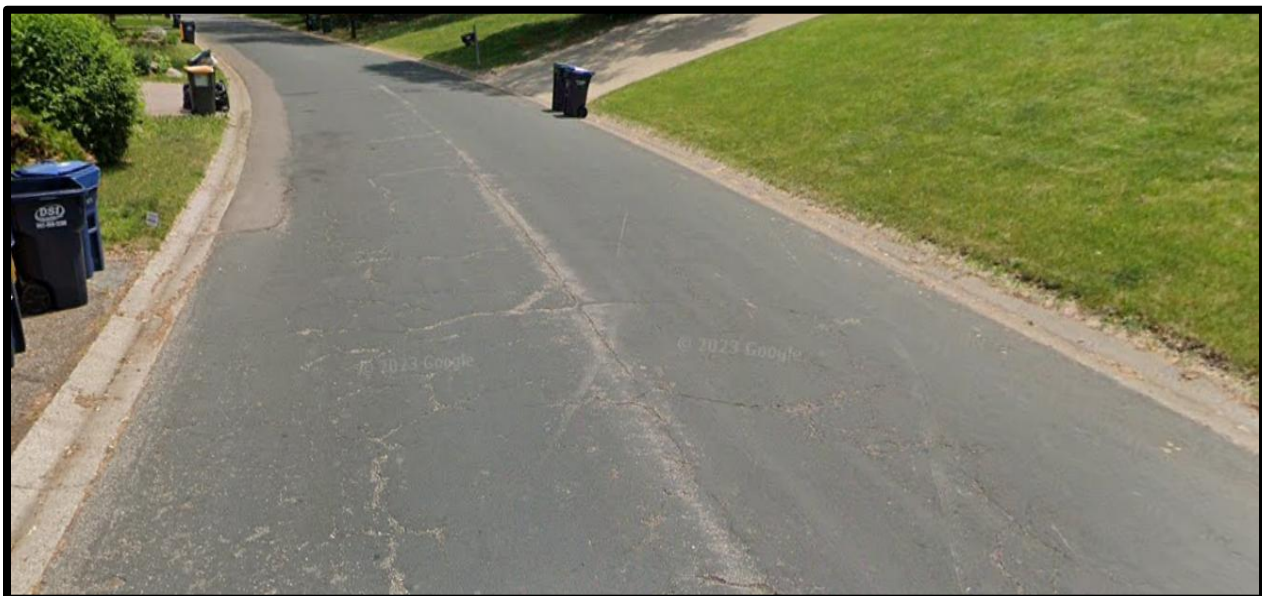
Photo 3. 178th Street West looking east toward Ipava Avenue.

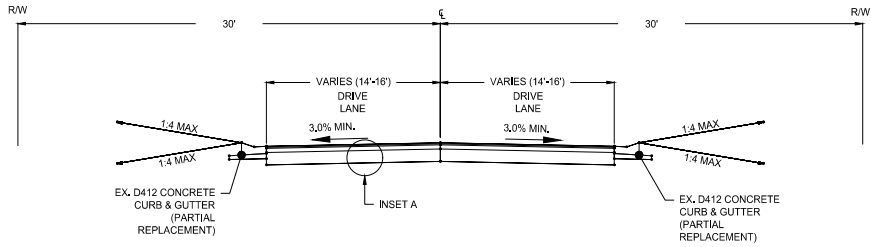
URBAN RESIDENTIAL - 1.5" DEPTH MILL

JASMINE AVENUE, JAGUAR PATH, 176TH STREET W, JAGUAR COURT, JALISCO PATH, JALISCO COURT, JAWHICA COURT, JASPER COURT, JAVELIN COURT, JASMINE COURT, INGRID COURT, JACQUARD PATH, JALISCO WAY, ITALY AVENUE, JAGUAR CIRCLE, IXONIA AVENUE, 177TH CIRCLE W, ITEN COURT N, ITEN COURT S, 180TH STREET W, ISLE AVENUE, IRONS COURT, 176TH COURT W, ISLETON AVENUE, ISLETON COURT, ITALY PATH, ITALY COURT (N.T.S.)

The local residential and minor collector streets within the project area will be milled and overlaid in accordance with the recommendations provided in the geotechnical report. **Appendix A** illustrates the proposed residential and minor collector roadway sections, which in general, consist of a new pavement layer of varying thickness over the existing bituminous road section. Certain areas have been identified by the Geotechnical Report as potentially needing a full depth mill and overlay or edge mill and overlay to remove the poor-quality pavement near the edges. These areas are limited to 176th Circle and Ixonia Avenue.

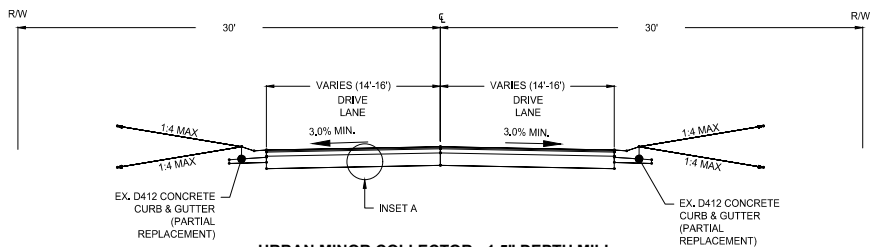
URBAN MINOR COLLECTOR - 1.5" DEPTH MILL

JAGUAR PATH
 178TH STREET W
 (N.T.S.)

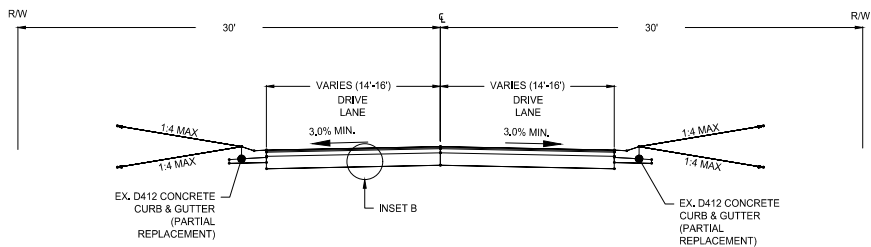
URBAN RESIDENTIAL - 2" DEPTH MILL

UPPER 178TH STREET W
 (N.T.S.)

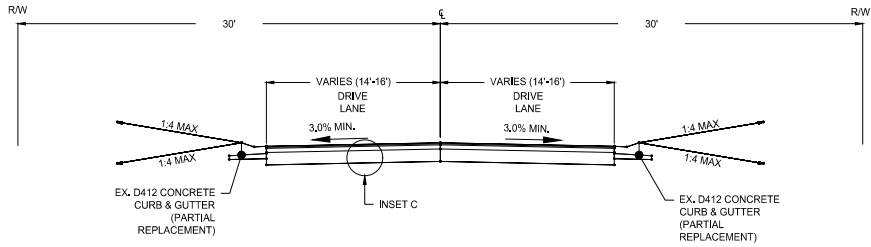
URBAN RESIDENTIAL - FULL DEPTH MILL

176TH CIRCLE W
(N.T.S.)

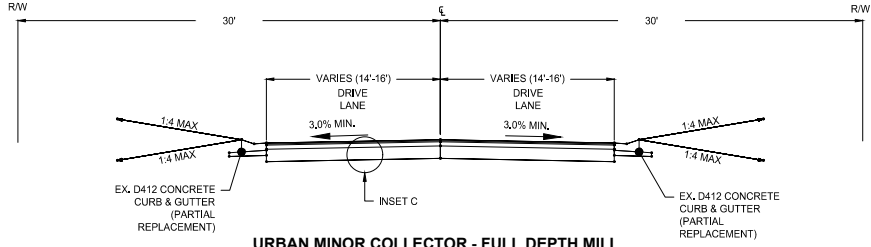
URBAN MINOR COLLECTOR - FULL DEPTH MILL

IXONIA AVENUE
(N.T.S.)

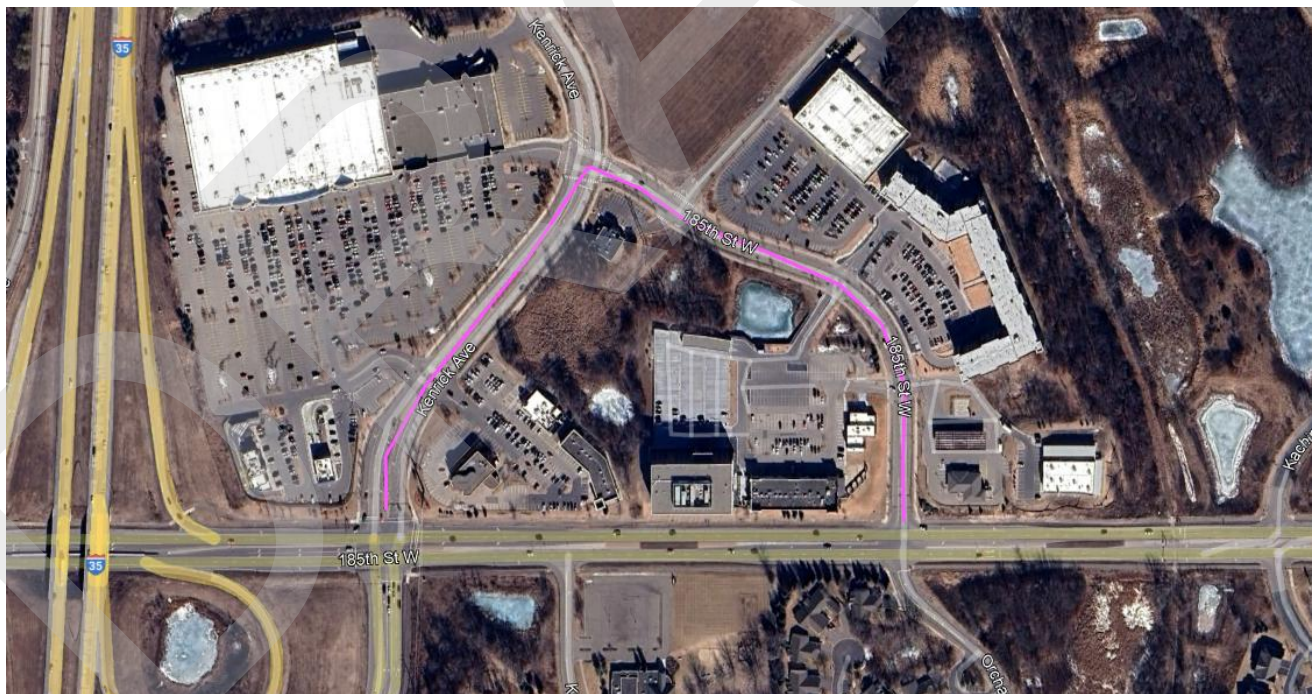
Figure 1-1. Existing roadway layout showing Kenrick Avenue (pink).

The roadways included within this project scope, with the notable exception to Kenrick Avenue, generally appear to be classified as local residential roadways with an Average Annual Daily Traffic (AADT) of less than 600 vehicles per day. Kenrick Avenue, based on MnDOT's Traffic Mapping Application, is classified as an Urban Major Collector and has a most recent AADT of 9490 (2022).

Figure 1-1 through Figure 1-6 below show an illustration of the existing roadway alignments.

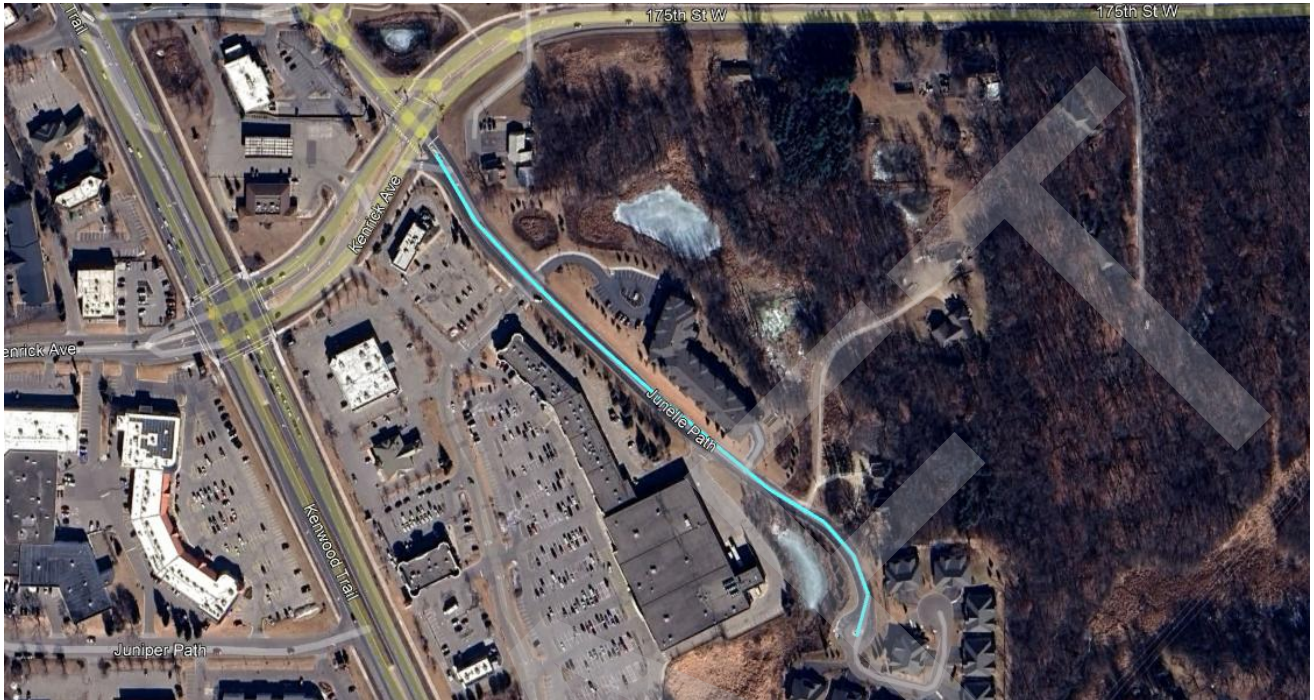
Figure 1-2. Existing roadway layout showing Junelle Path (light blue)
Figure taken from Google Earth

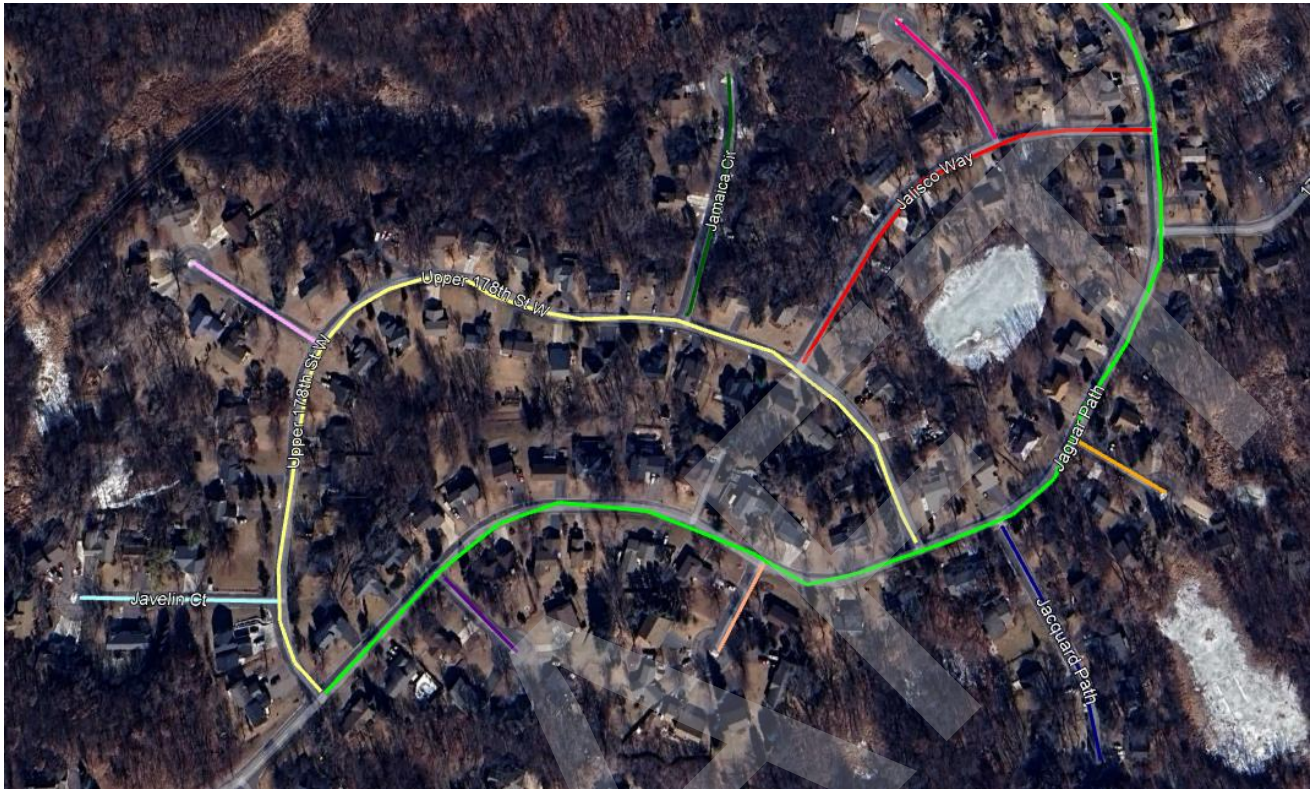
Figure 1-3. Existing roadway layout showing Javelin Court (light blue), Jasper Court (light pink), Upper 178th Street West (yellow), Jamaica Circle (dark green), Jalisco Way (red), Jalisco Court (pink), Jaguar Path (green), Jaguar Circle (dark yellow), Jacquard Path (blue), Ingrid Court (orange), and Jasmine Court (purple)

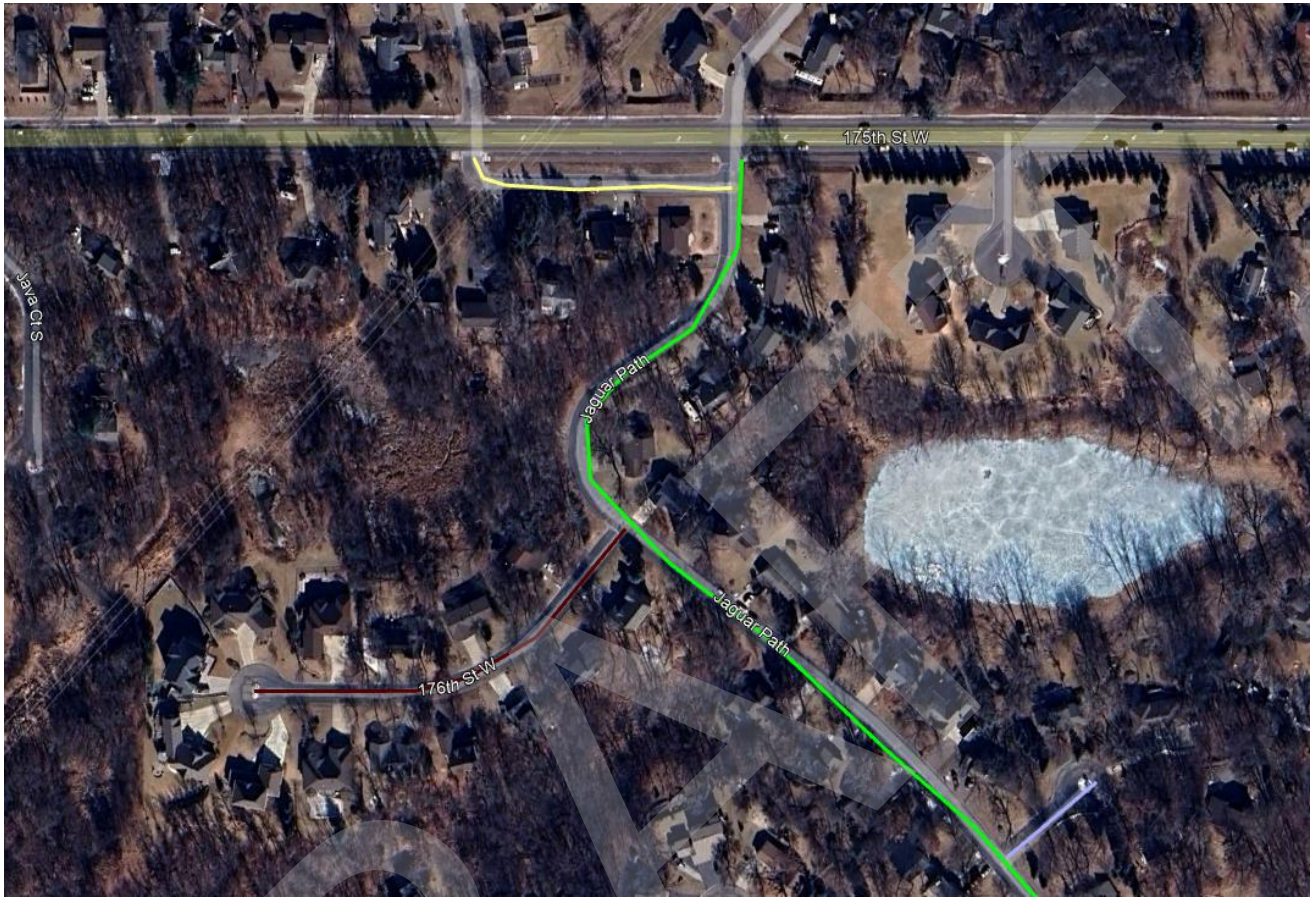
Figure 1-4. Existing roadway layout showing Jaguar Path (green), Jasmine Avenue (yellow), 176th Street West (brown), and Jaguar Court (light purple)

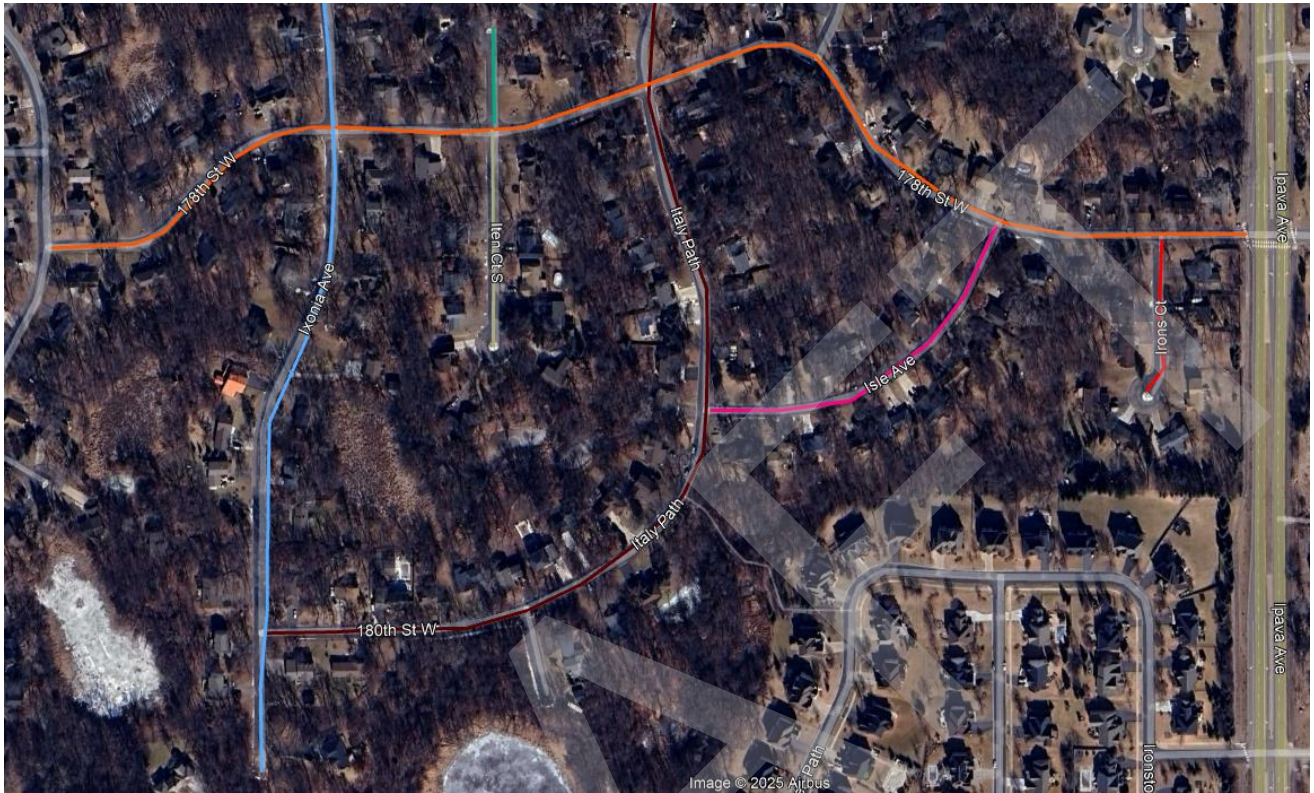
Figure 1-5. Existing roadway layout showing 178th Street West (orange), Ixonia Avenue (blue), Iten Court North (green), Iten Court South (light green), Italy Path (brown), Isle Avenue (pink), and Irons Court (red)
Figure taken from Google Earth.

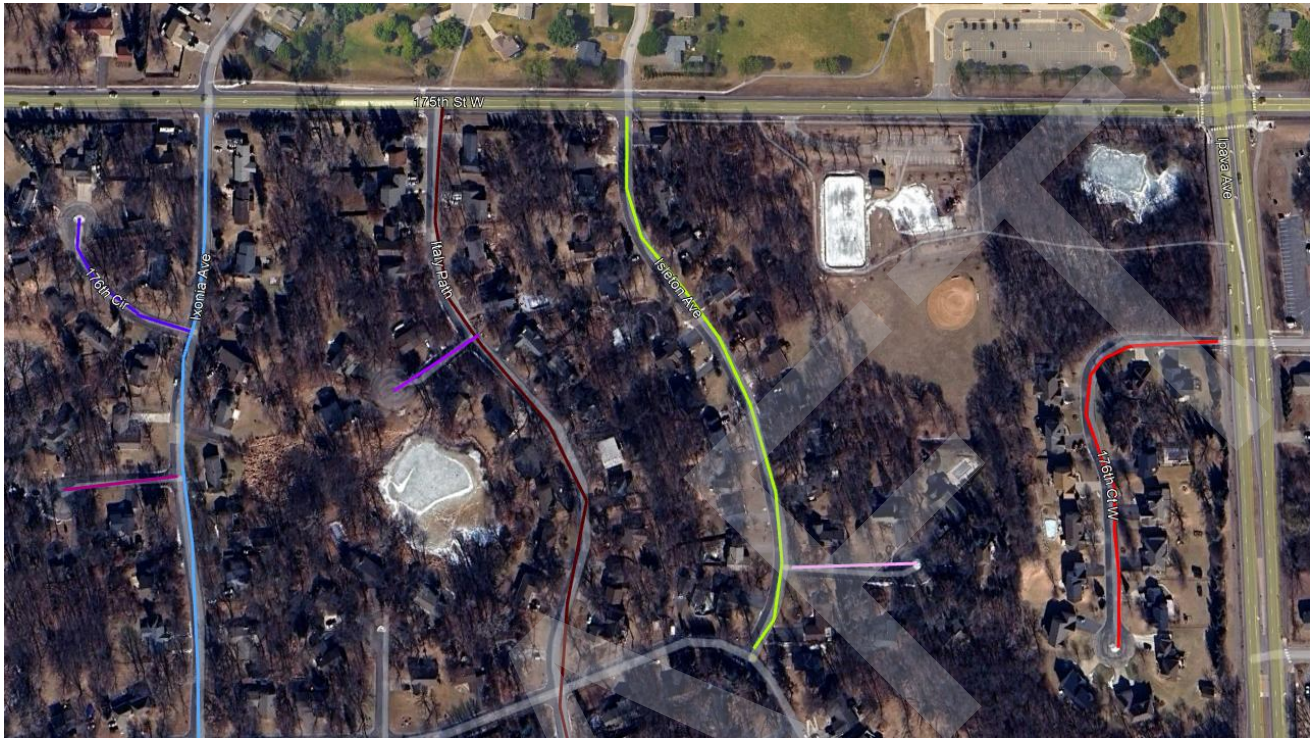
Figure 1-6. Existing roadway layout showing 176th Circle (purple), Ixonia Ave (light blue), 177th Circle West (dark pink), Italy Path (brown), Italy Court (light purple), Isleton Avenue (light green), Isleton Court (light pink), and 176th Court West (red)

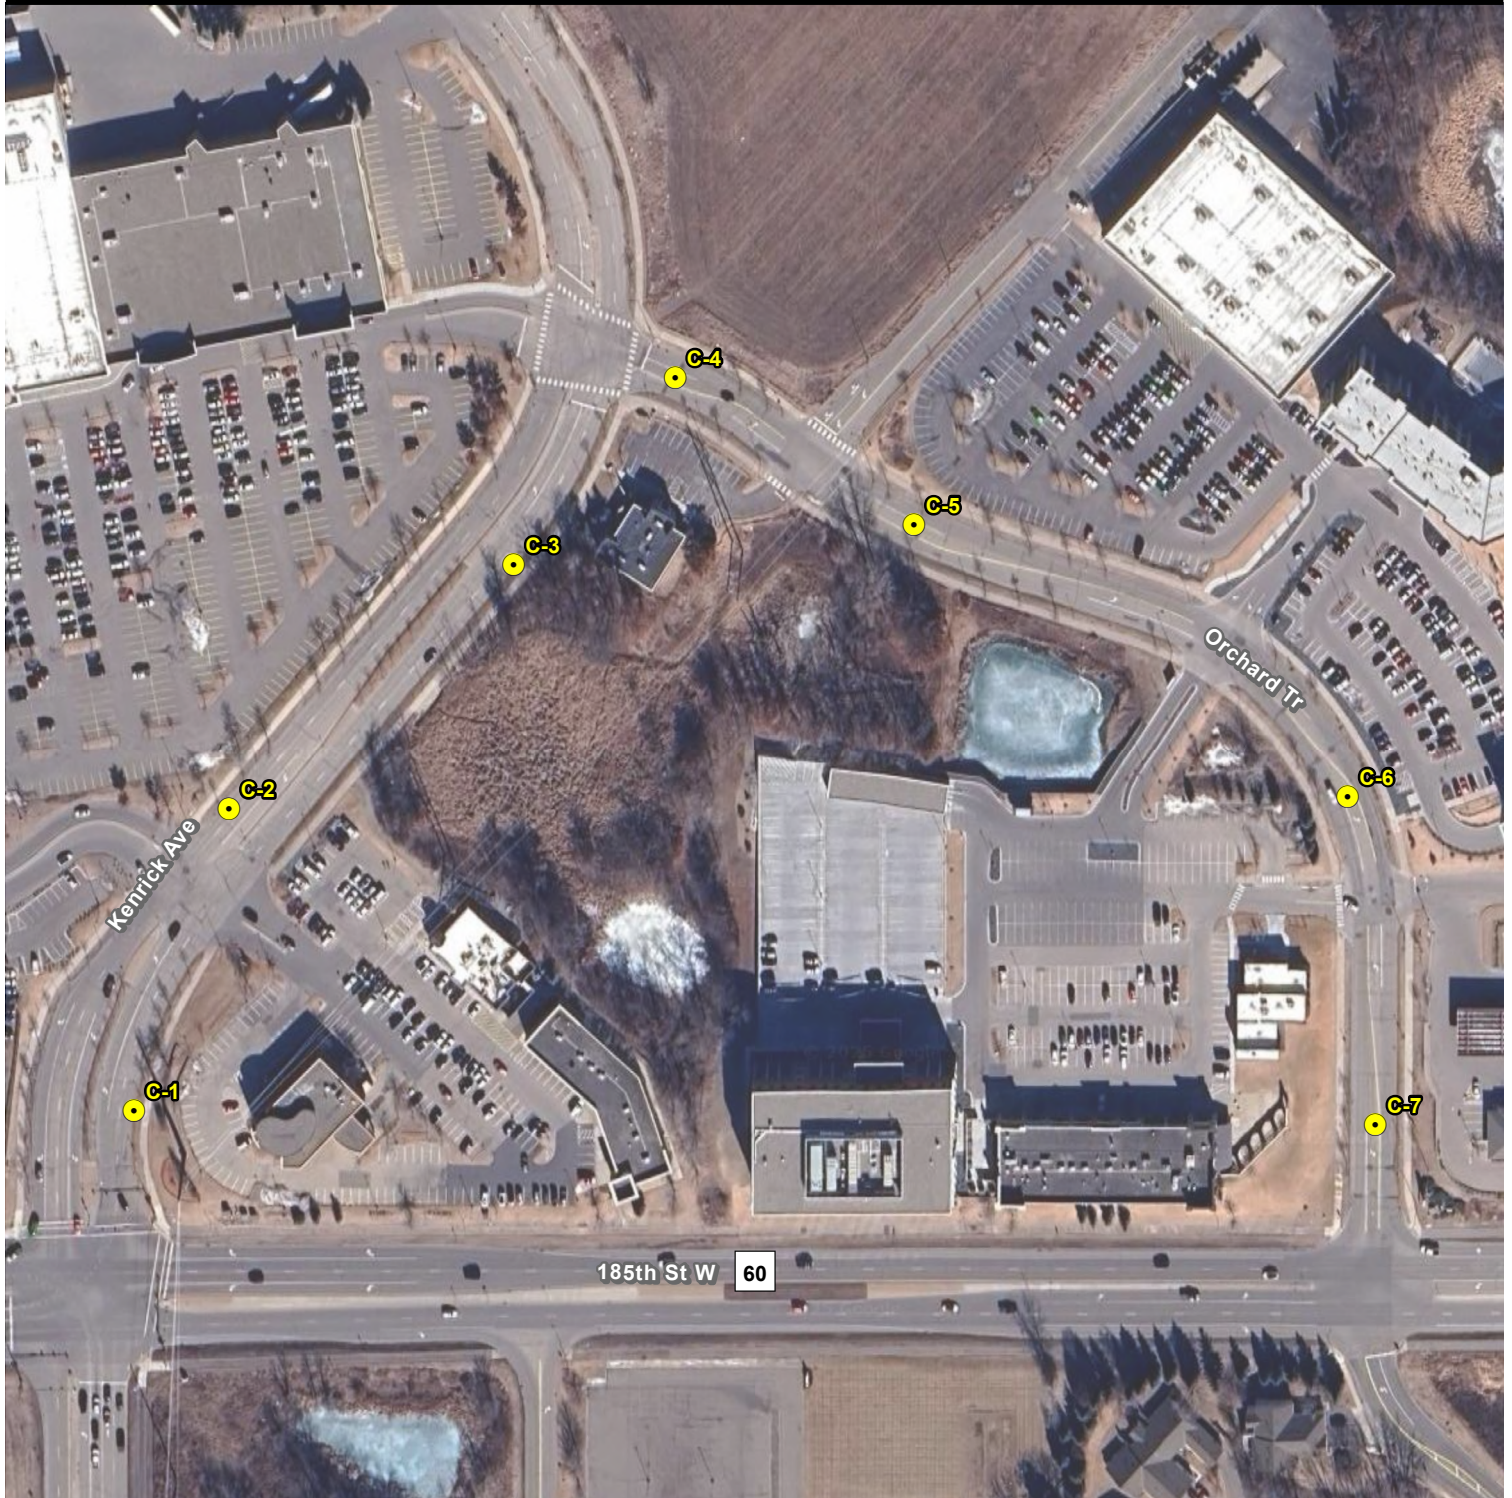
Sheet:
1 of 3

**Boring and Coring
Location Sketch**

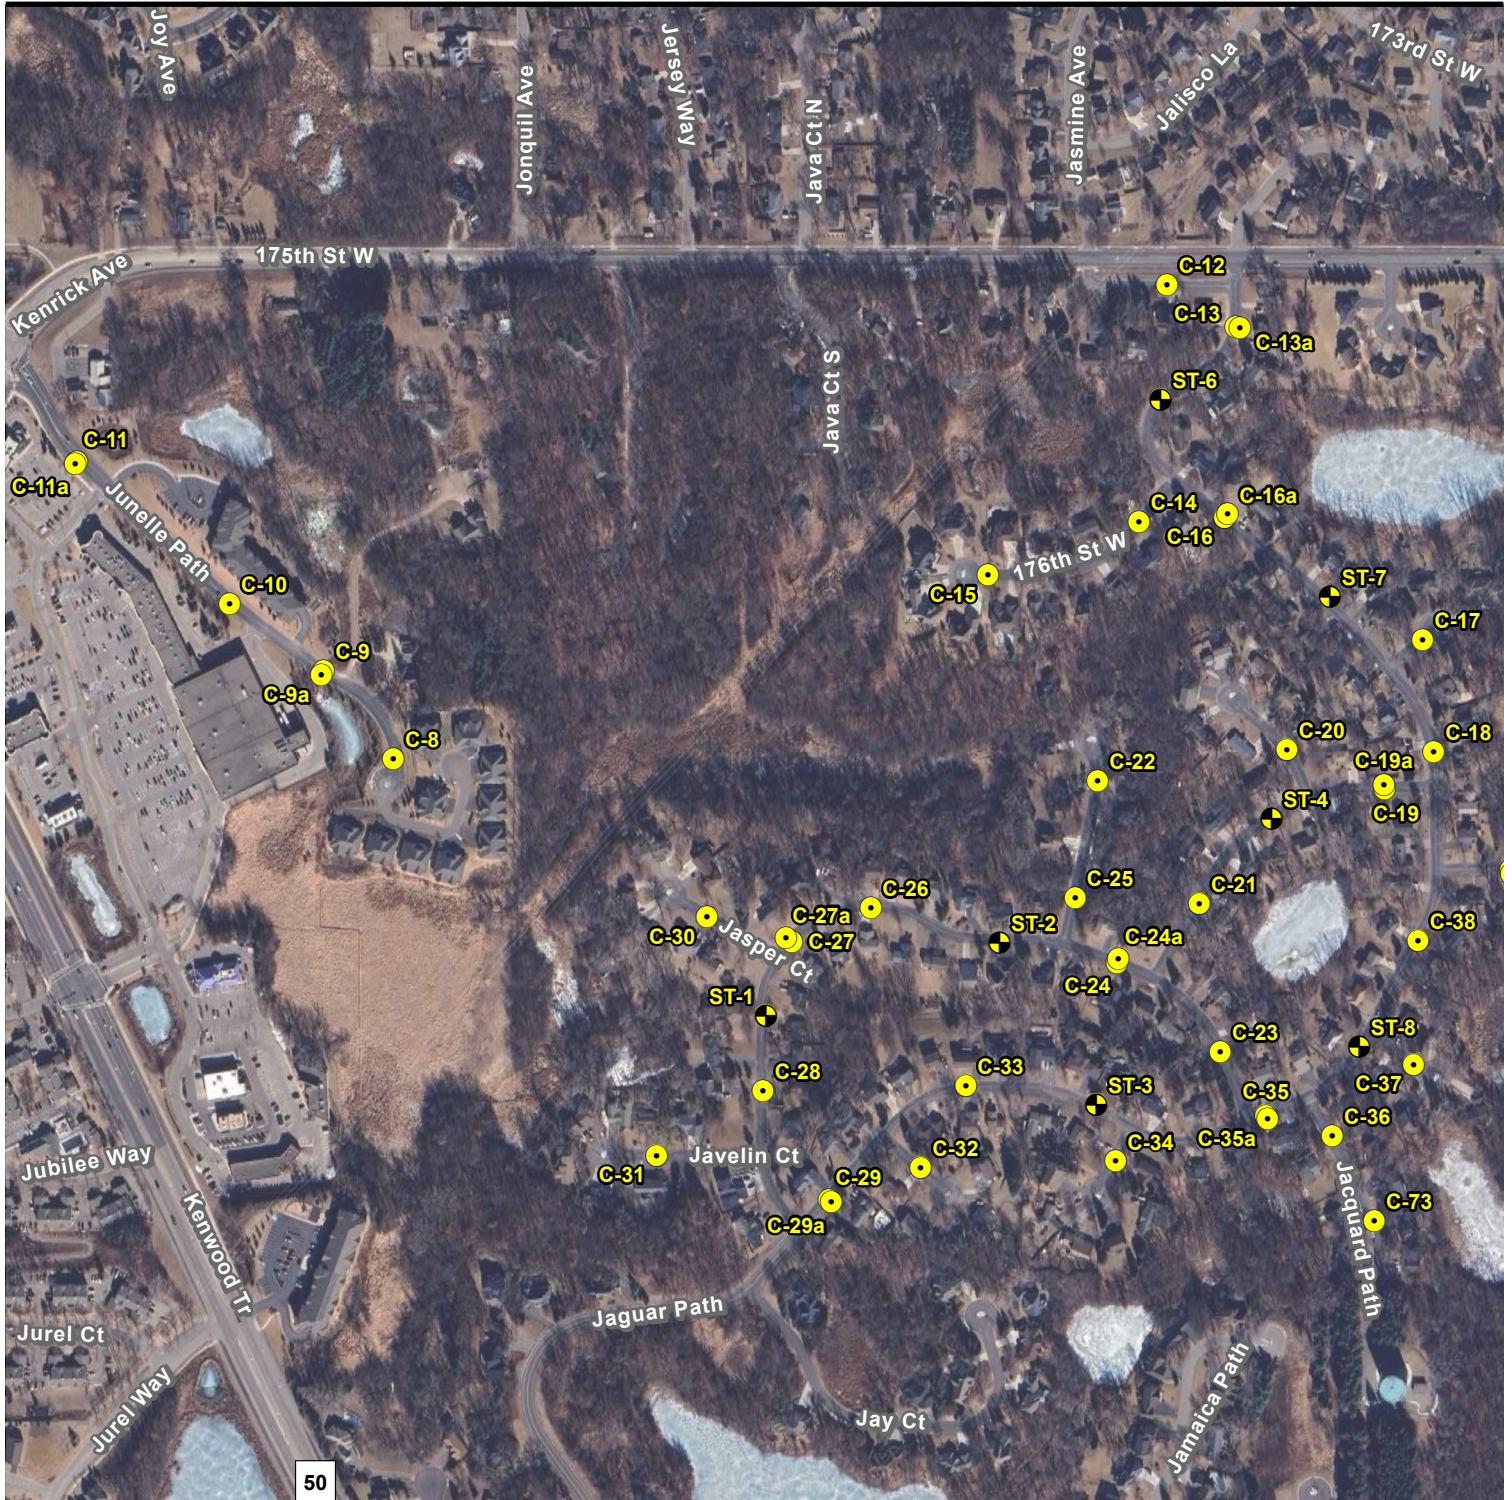
Sheet:
2 of 3

**Boring and Coring
Location Sketch**

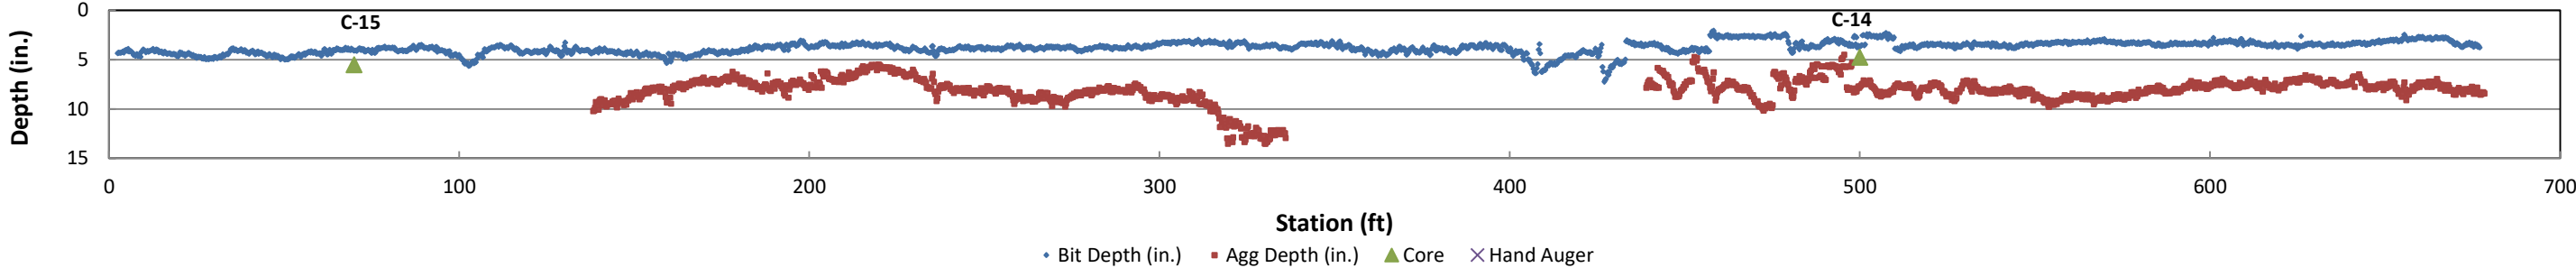
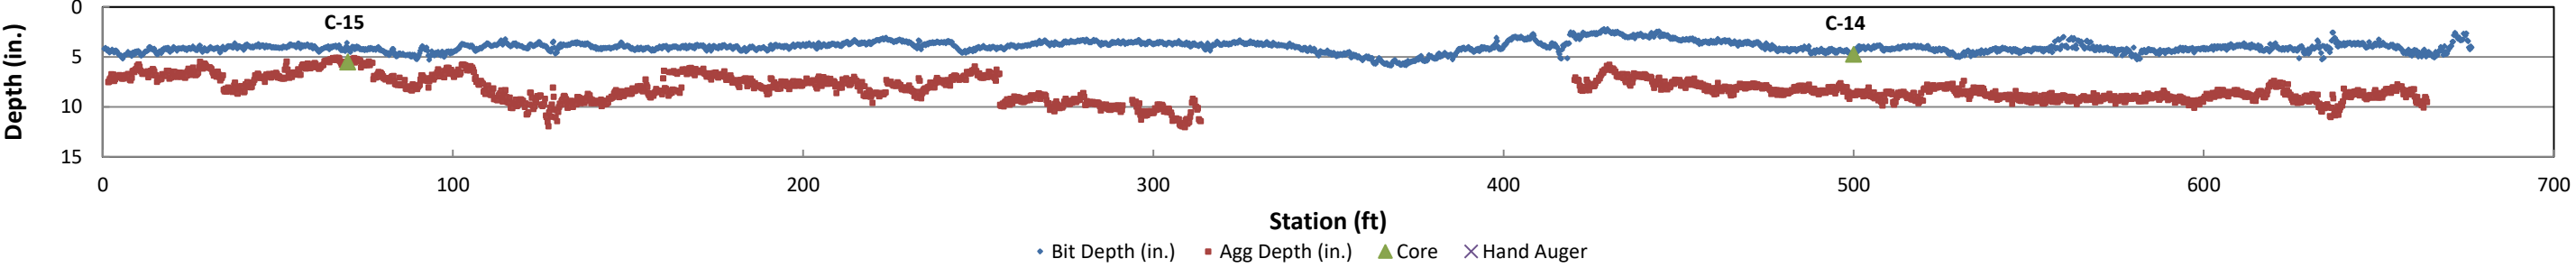
GPR Results: 177th Circle West - Cul-de-sac to Ixonia Ave

Note: stations are positive in the NB or EB direction; SB or WB scans have been reversed

176th Street West (EB)

176th Street West (WB)

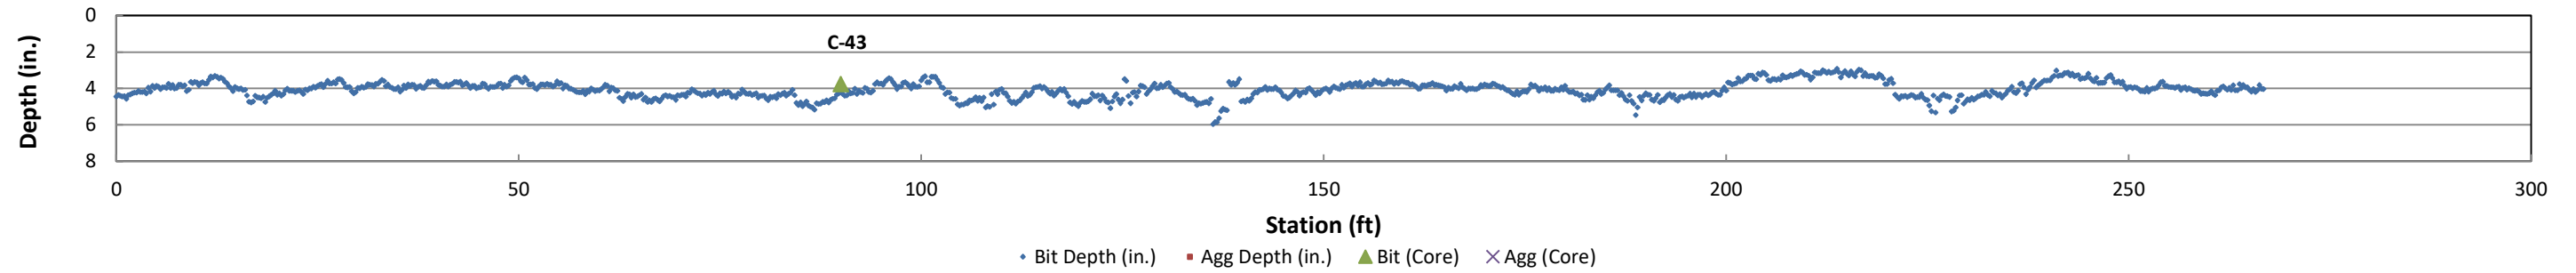
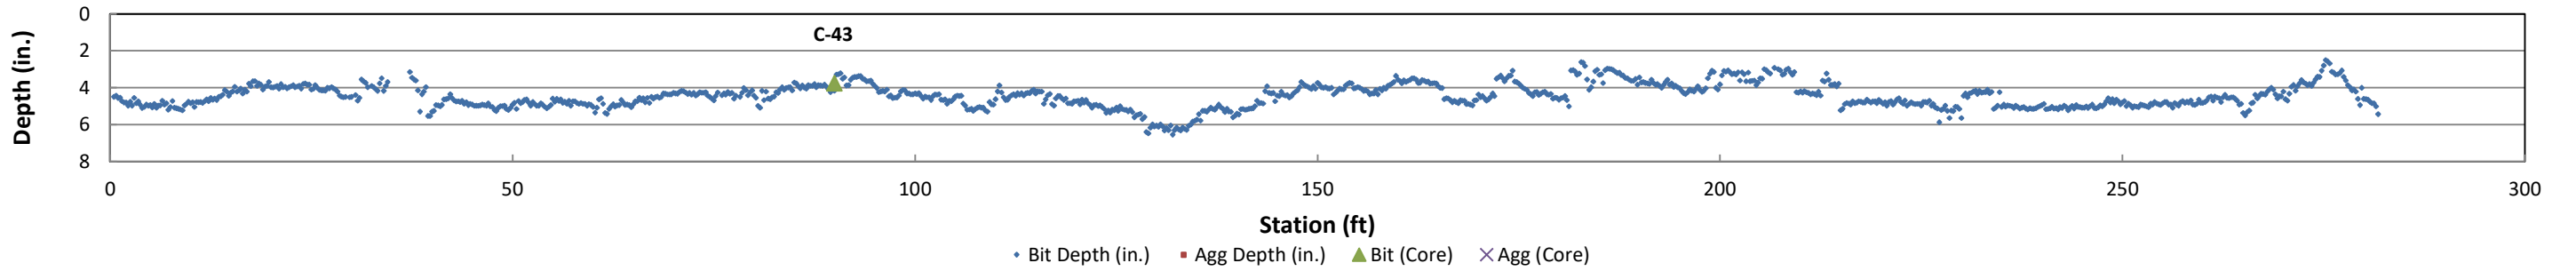
GPR Results: 178th Street West - Jaguar Path to Ipava Avenue

Note: stations are positive in the NB or EB direction; SB or WB scans have been reversed

177th Circle West (EB)

177th Circle West (WB)

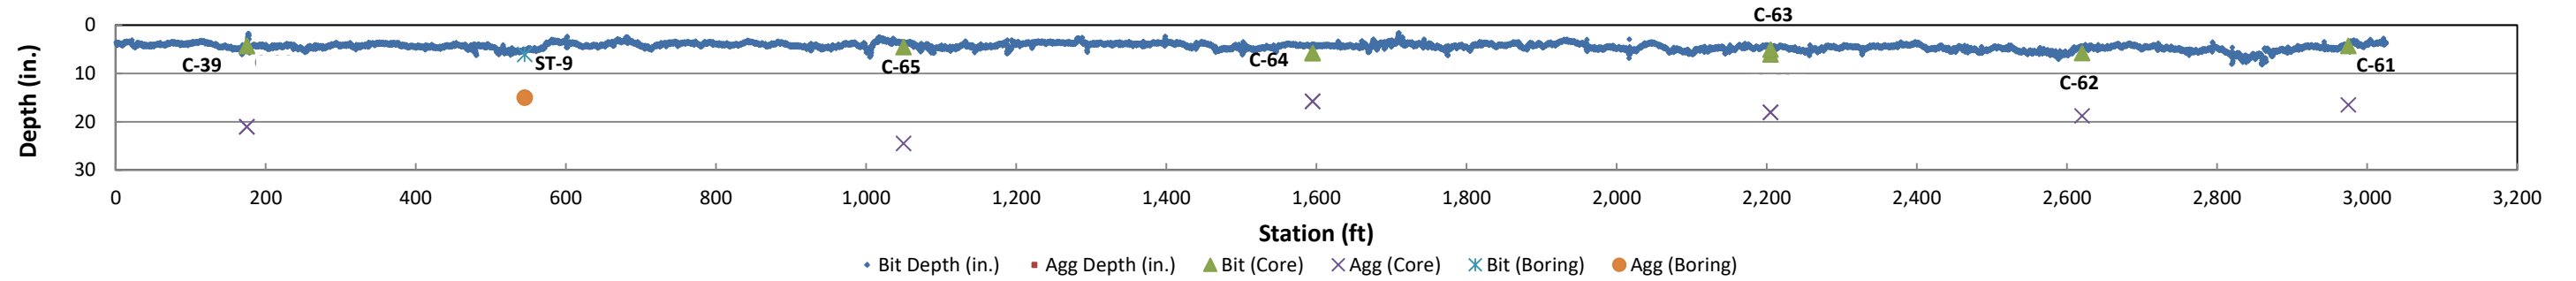
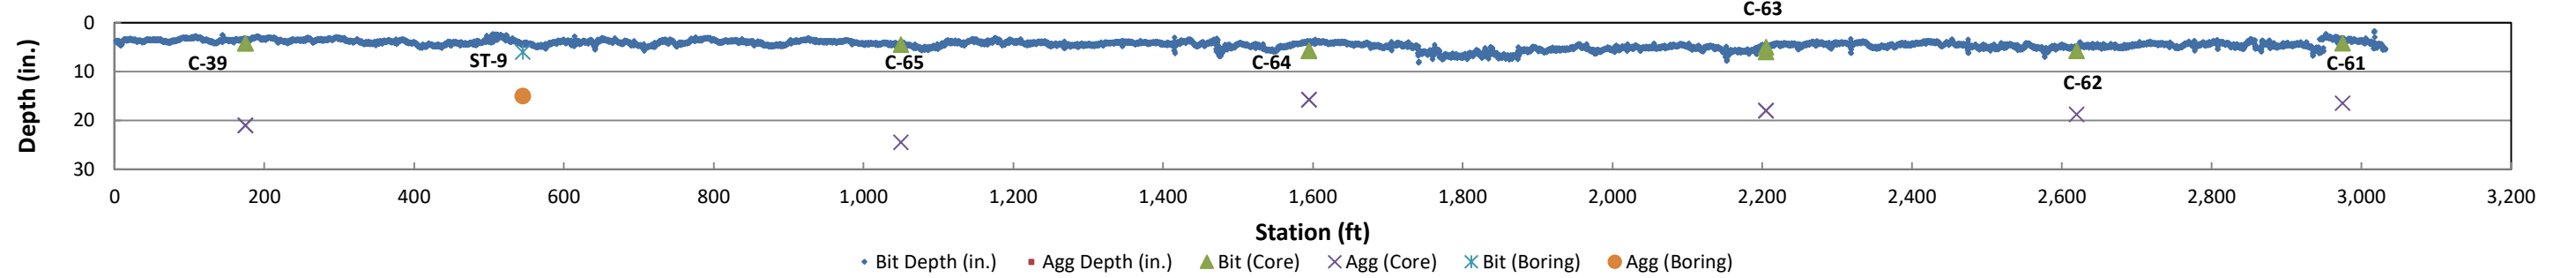
GPR Results: Ingrid Court - Cul-de-sac to Jaguar Path

Note: stations are positive in the NB or EB direction; SB or WB scans have been reversed

178th Street West (EB)

178th Street West (WB)

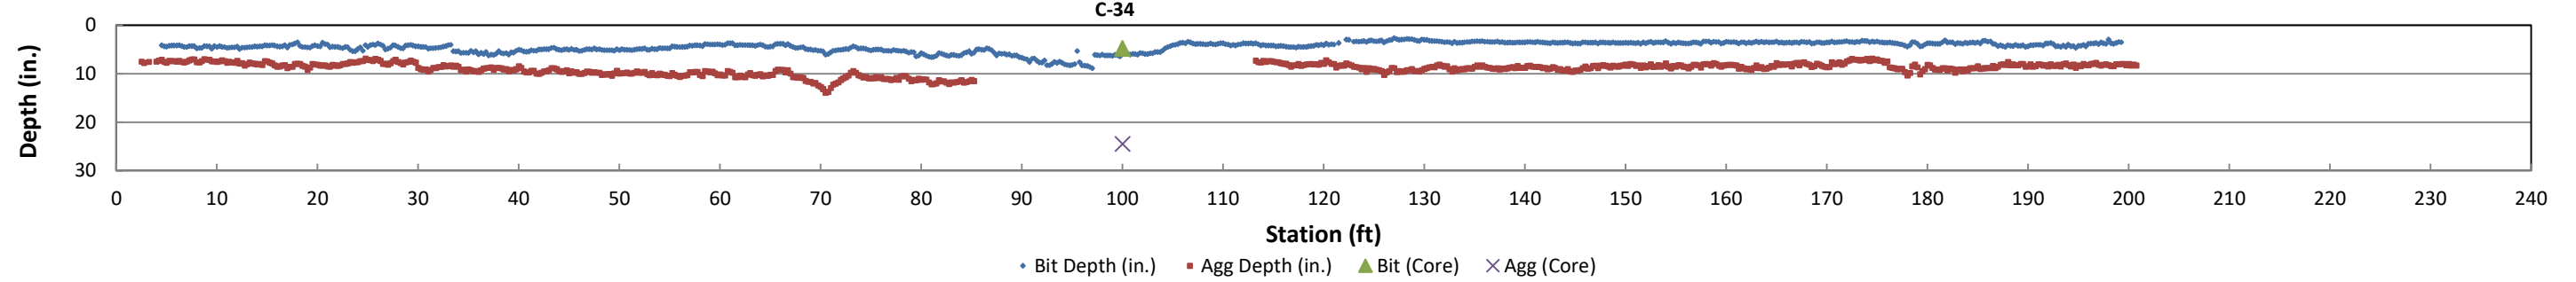
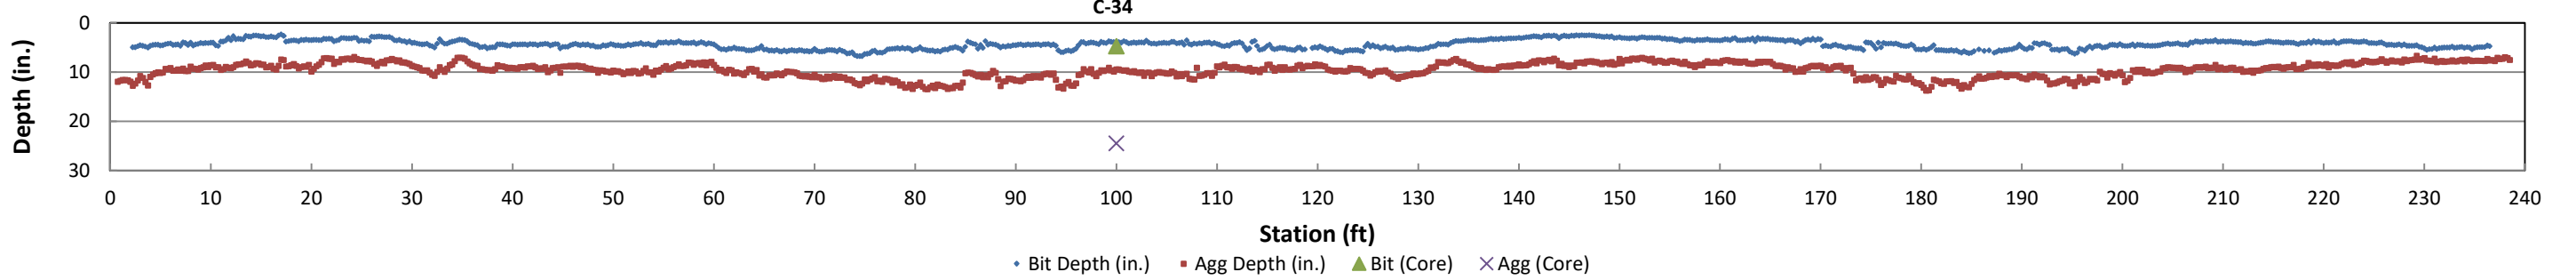
Note: stations are positive in the NB or EB direction; SB or WB scans have been reversed

Ingrid Court (NB)

Ingrid Court (SB)

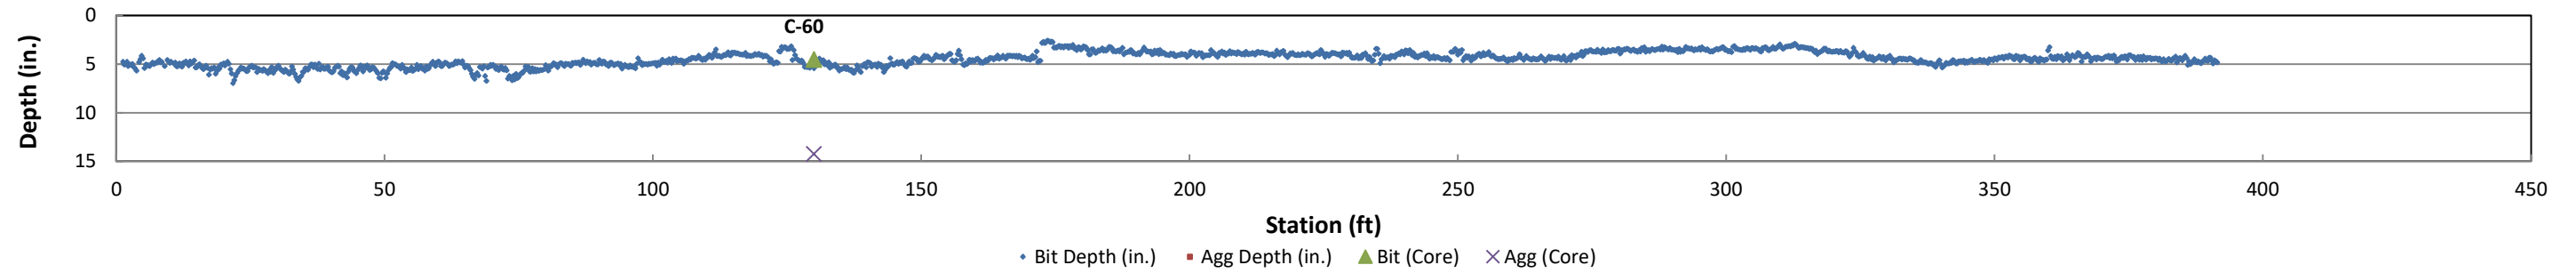
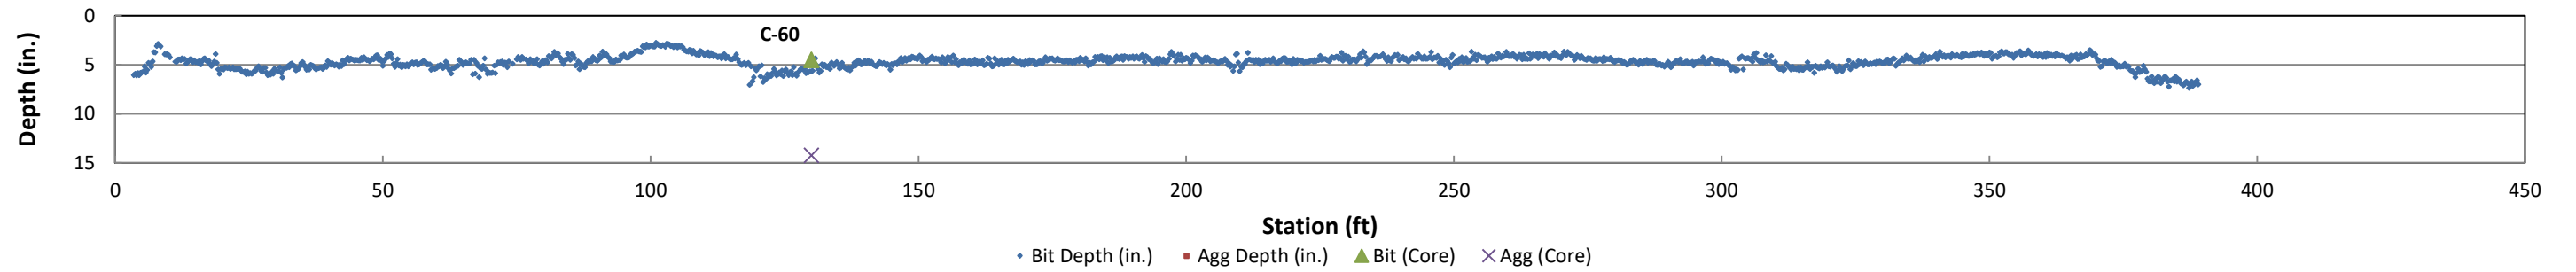
Location City of Lakeville 26-01
 Project No. B2506309
 Roadway Irons Court
 From Cul-de-sac
 To 178th Street West

Note: stations are positive in the NB or EB direction; SB or WB scans have been reversed

Irons Court (NB)

Irons Court (SB)
