ENGINEERING REPORT

2026 STREET REHABILITATION PROJECT

November 25, 2025

CITY PROJECT NO. 26-02

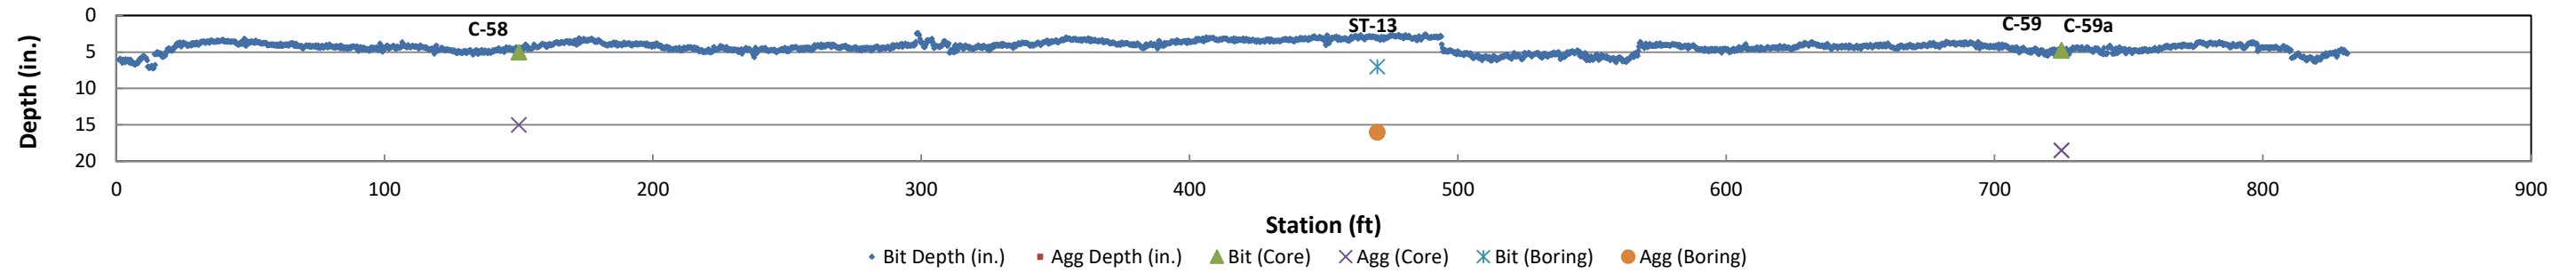
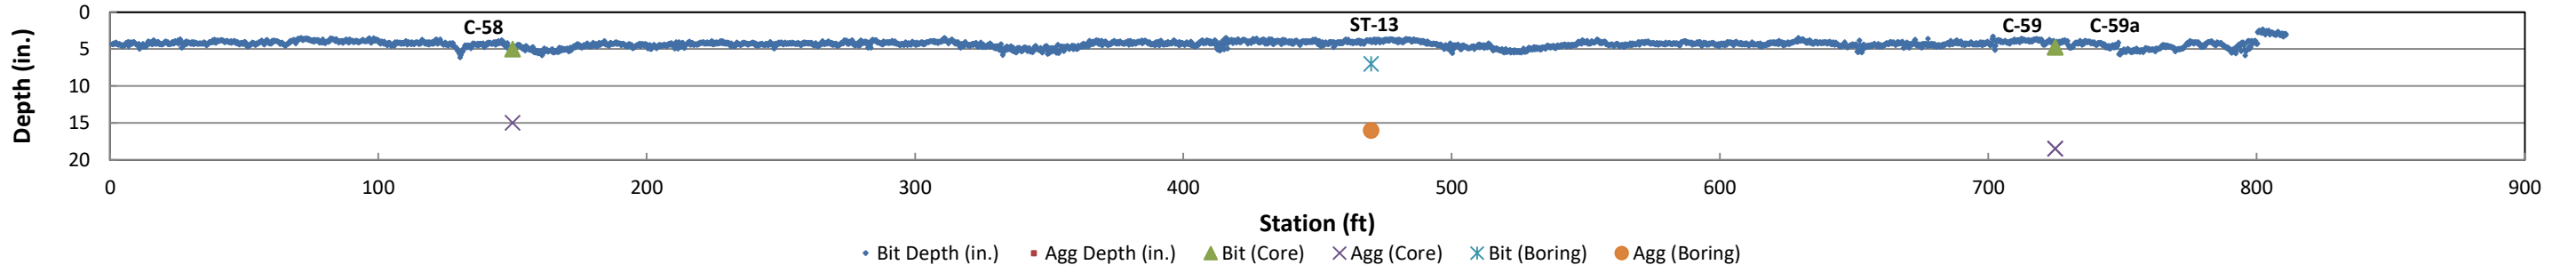
GPR Results: Isleton Avenue - 178th Street West to 175th Street West

Note: stations are positive in the NB or EB direction; SB or WB scans have been reversed

Isle Avenue (EB)

Isle Avenue (WB)

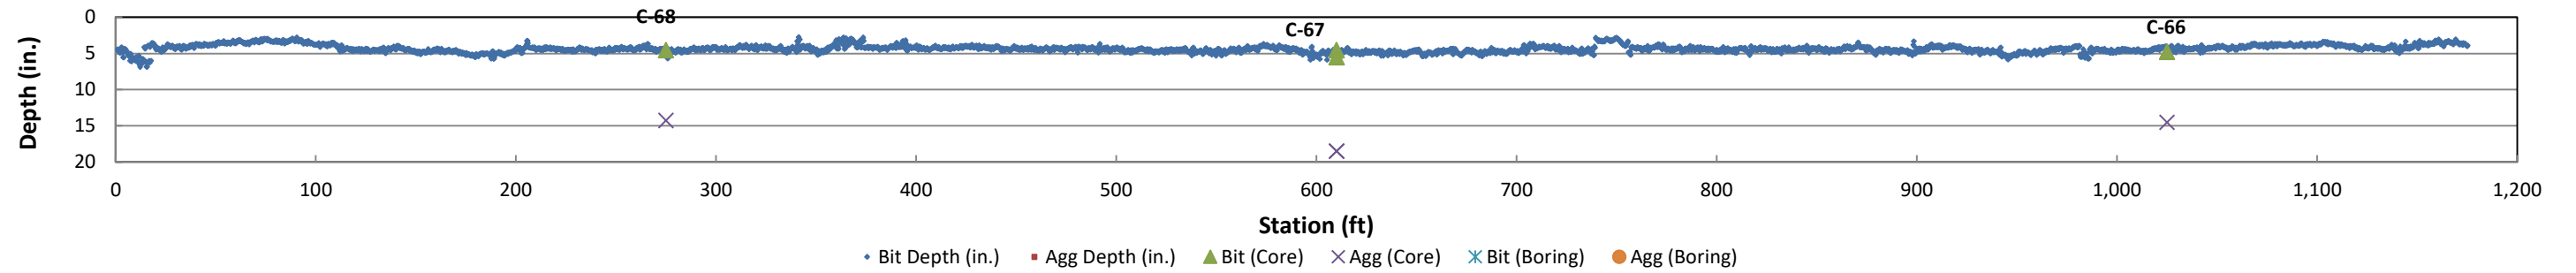
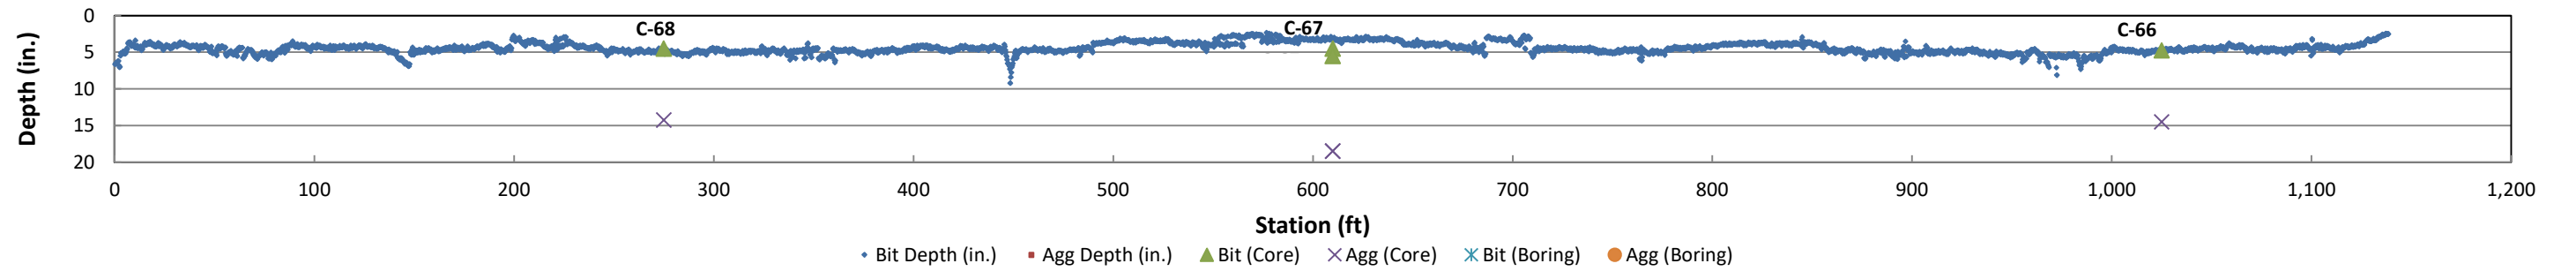
GPR Results: Isleton Court - Isleton Avenue to Cul-de-sac

Note: stations are positive in the NB or EB direction; SB or WB scans have been reversed

Isleton Avenue (NB)

Isleton Avenue (SB)

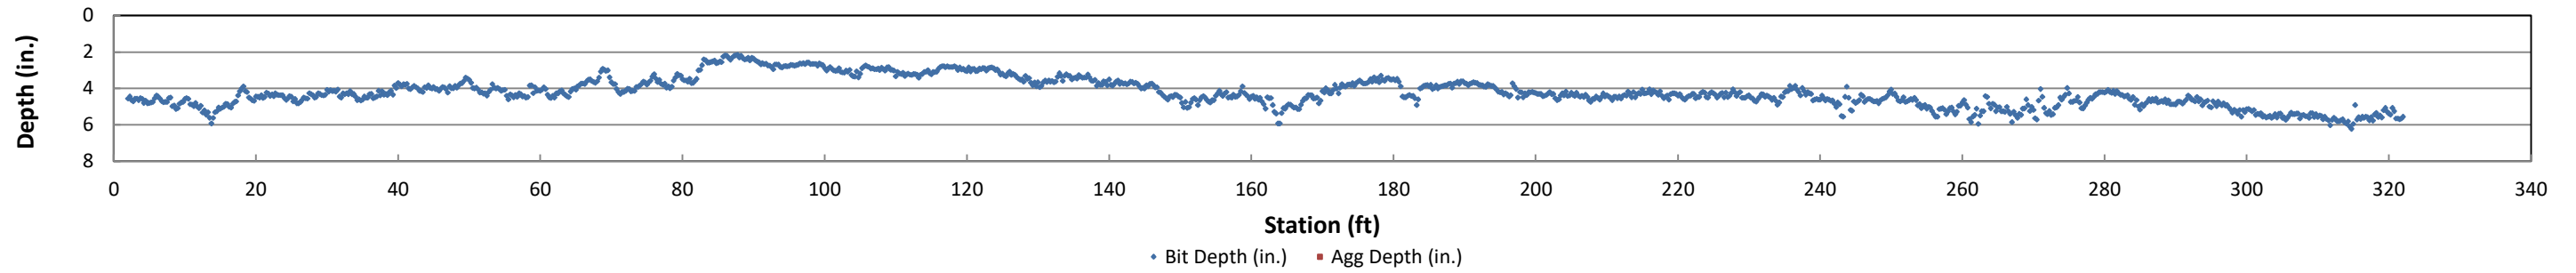
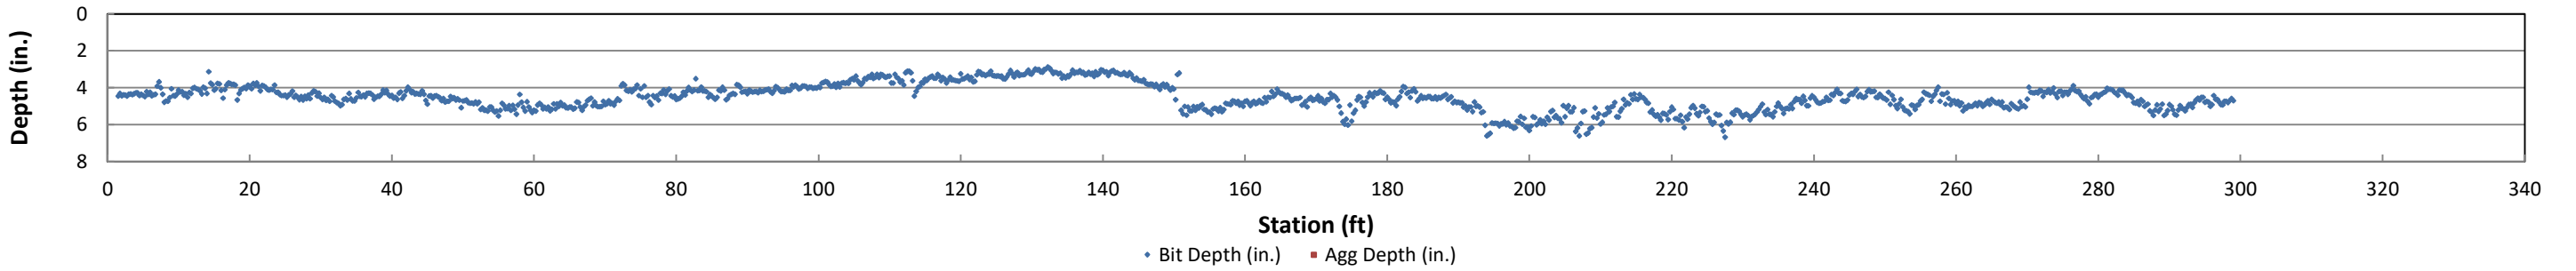
GPR Results: Italy Court - Cul-de-sac to Italy Path

Note: stations are positive in the NB or EB direction; SB or WB scans have been reversed

Isleton Court (EB)

Isleton Court (WB)

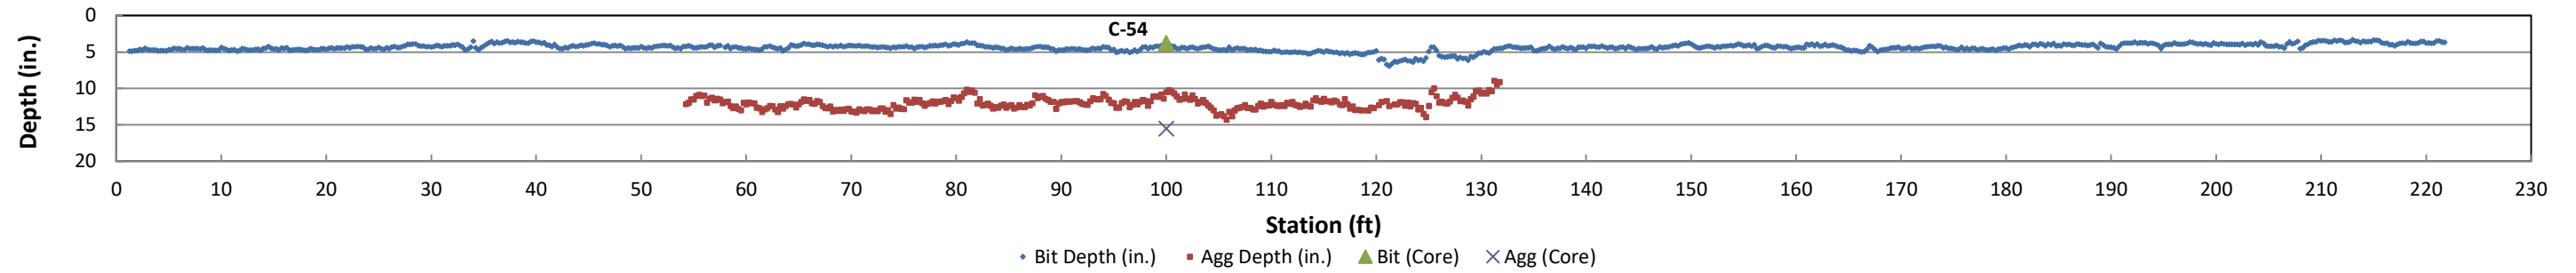
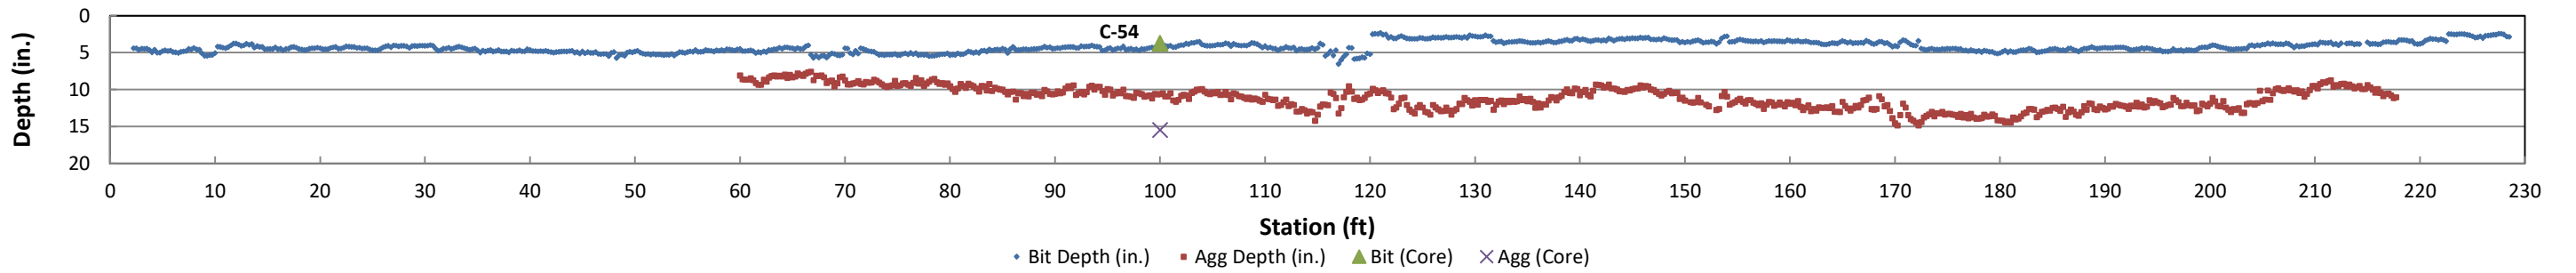
GPR Results: Italy Path - Ixonia Avenue to 175th Street West

Note: stations are positive in the NB or EB direction; SB or WB scans have been reversed

Italy Court (EB)

Italy Court (WB)

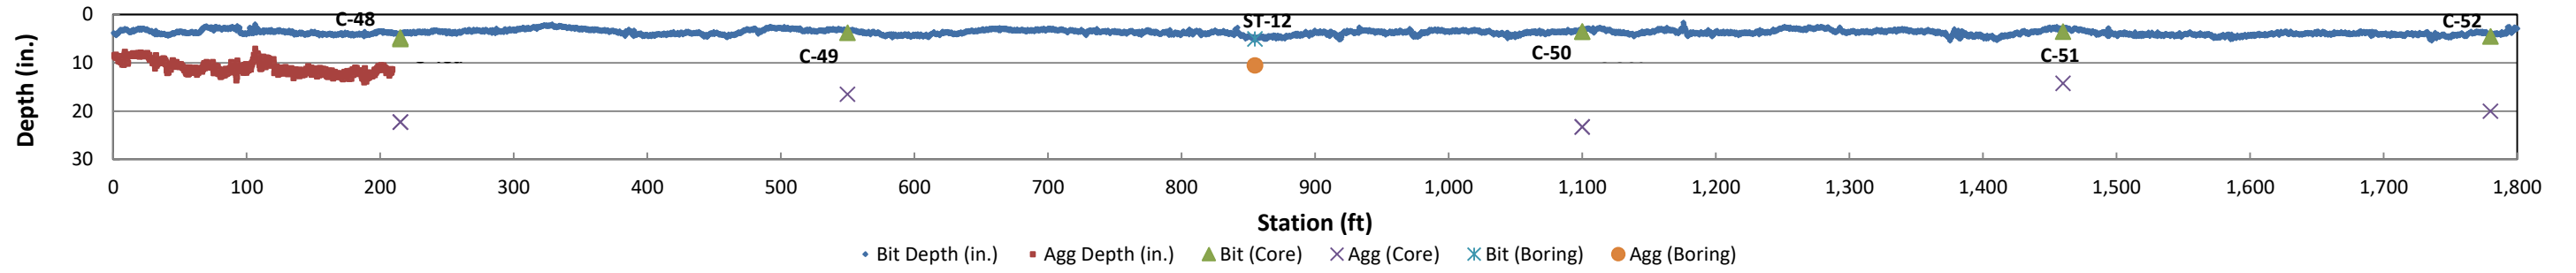
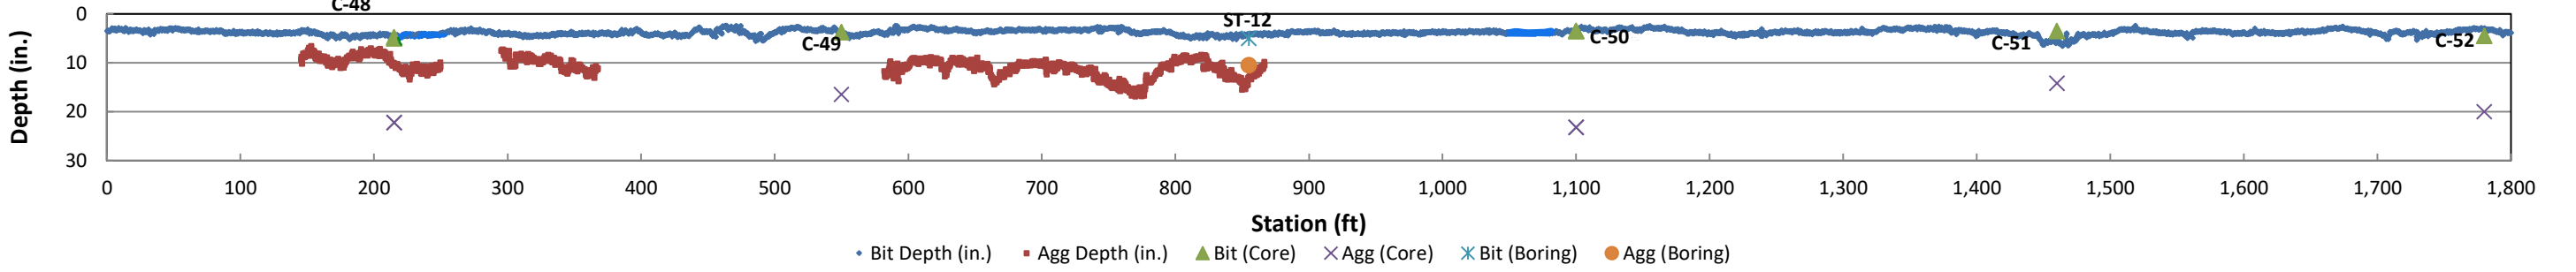
Note: stations are positive in the NB or EB direction; SB or WB scans have been reversed

Italy Path (NB)

Italy Path (SB)

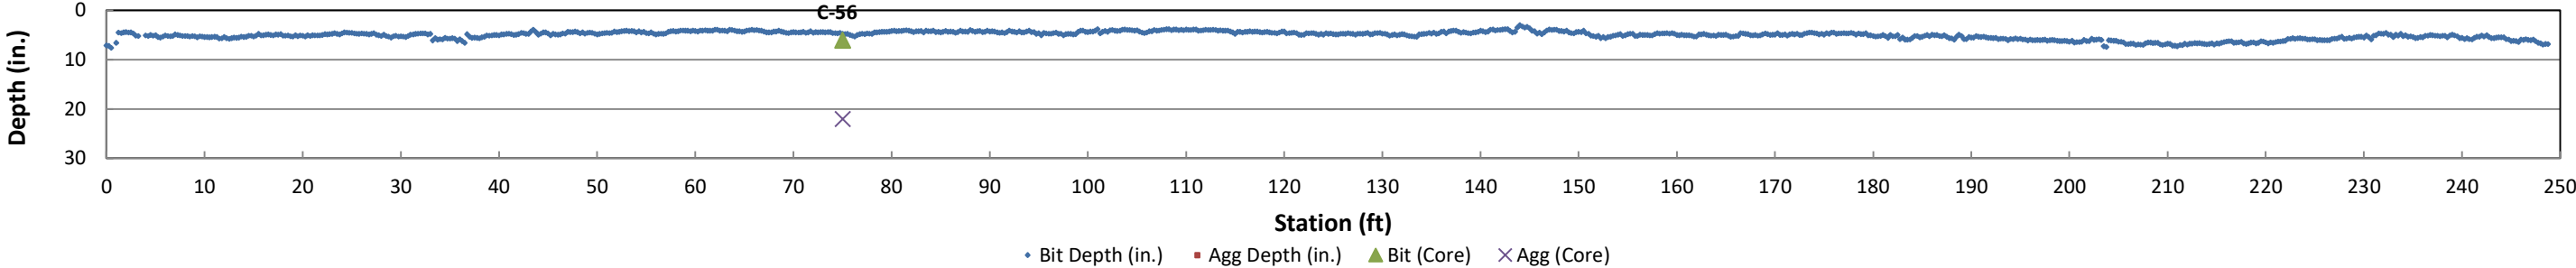
Iten Court North (NB)

GPR Results: Iten Court North - 178th Street West to Cul-de-sac

Note: stations are positive in the NB or EB direction; SB or WB scans have been reversed

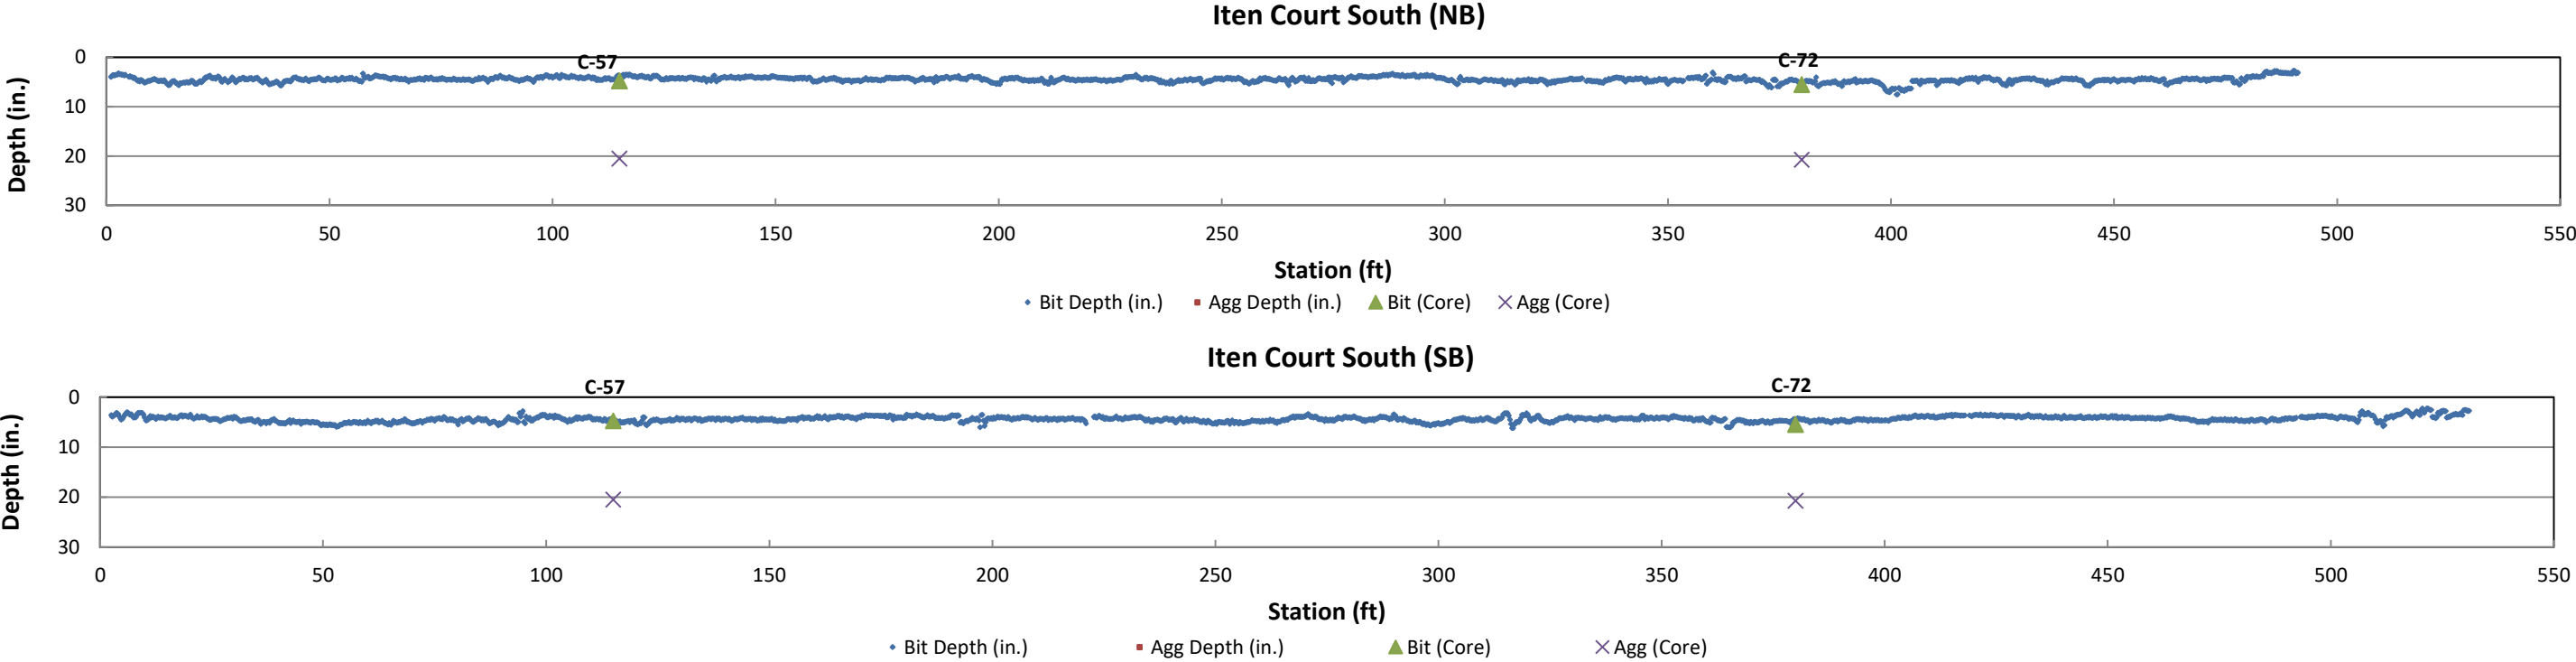
GPR Results: Iten Court South - Cul-de-sac to 178th Street West

Note: stations are positive in the NB or EB direction; SB or WB scans have been reversed

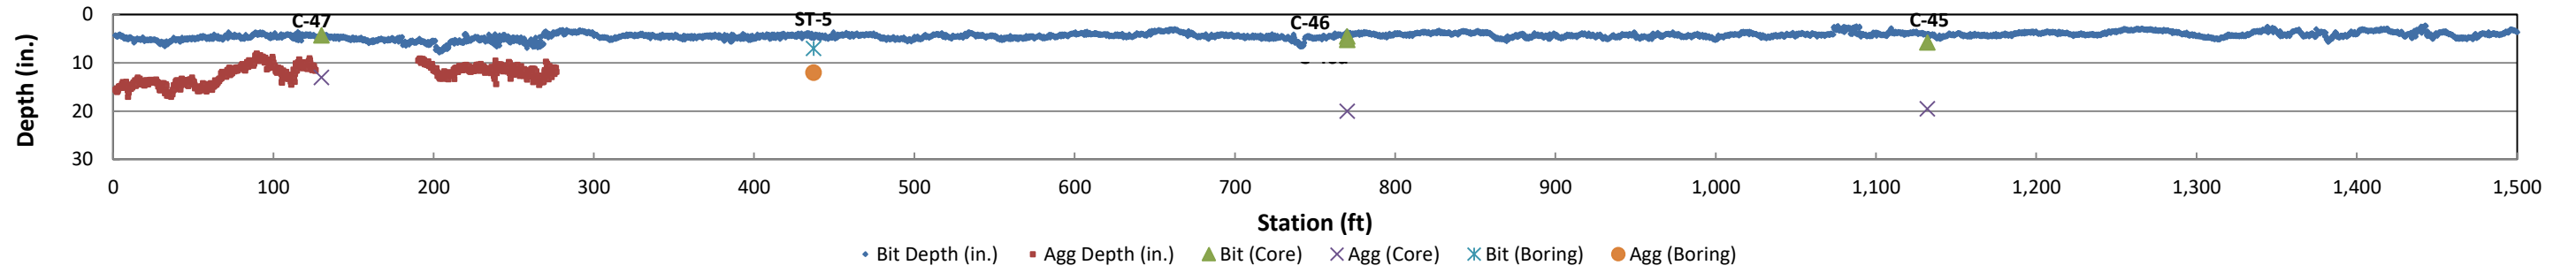
Ixonia Avenue (NB)

GPR Results: Ixonia Avenue - Cul-de-sac to 175th Street West

Note: stations are positive in the NB or EB direction; SB or WB scans have been reversed

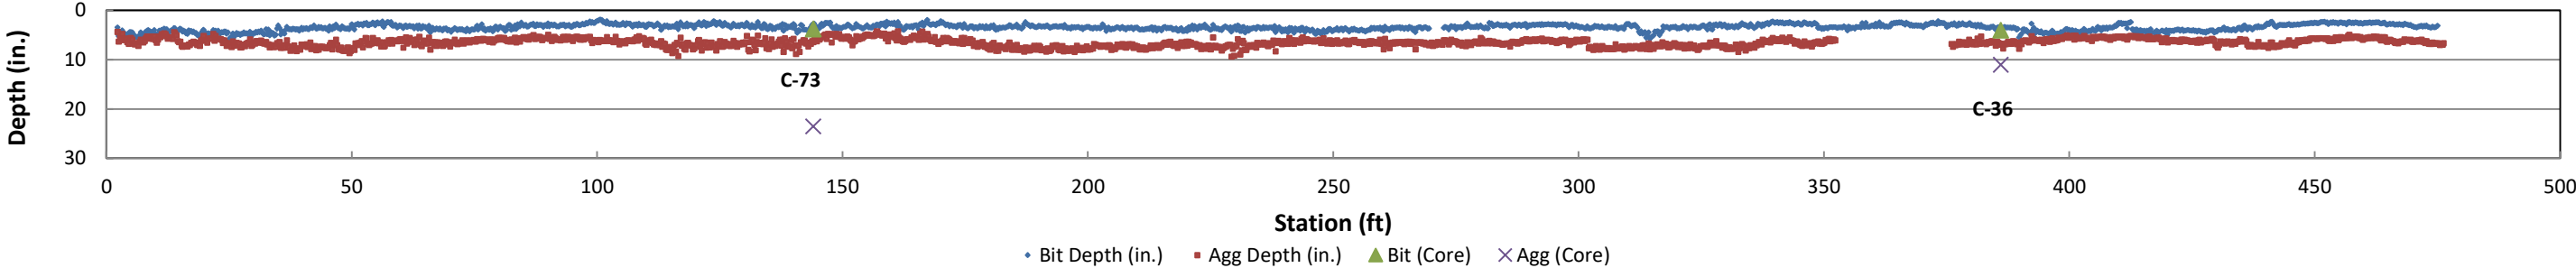
Jacquard Path (NB)

GPR Results: Jacquard Path - Cul-de-sac to Jaguar Path

Note: stations are positive in the NB or EB direction; SB or WB scans have been reversed

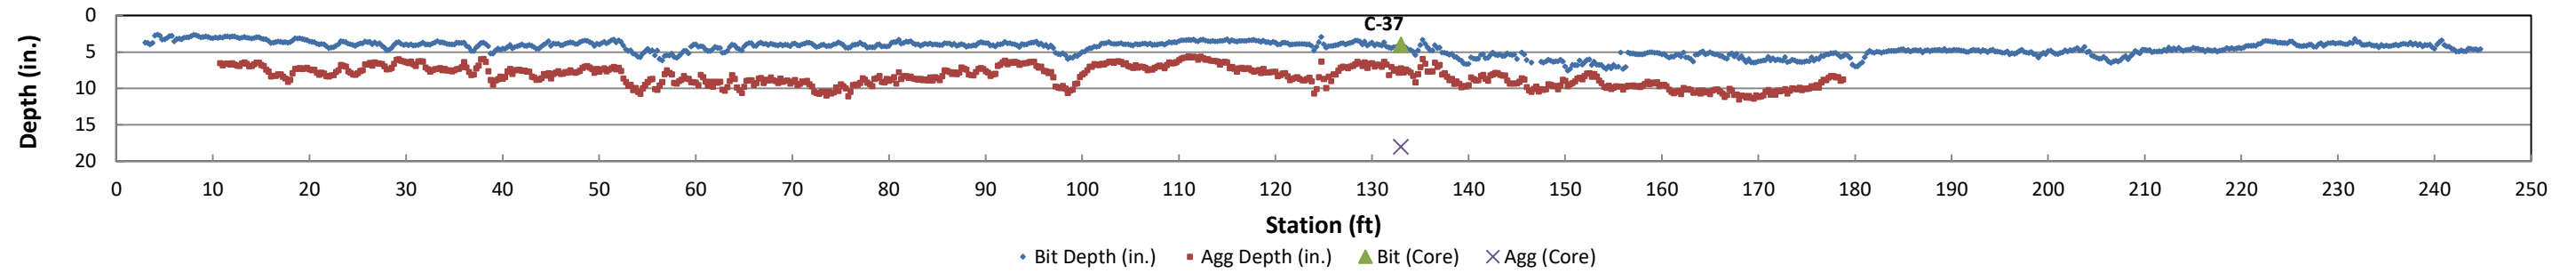
Jaguar Circle (EB)

GPR Results: Jaguar Circle - Jaguar Path to Cul-de-sac

Note: stations are positive in the NB or EB direction; SB or WB scans have been reversed

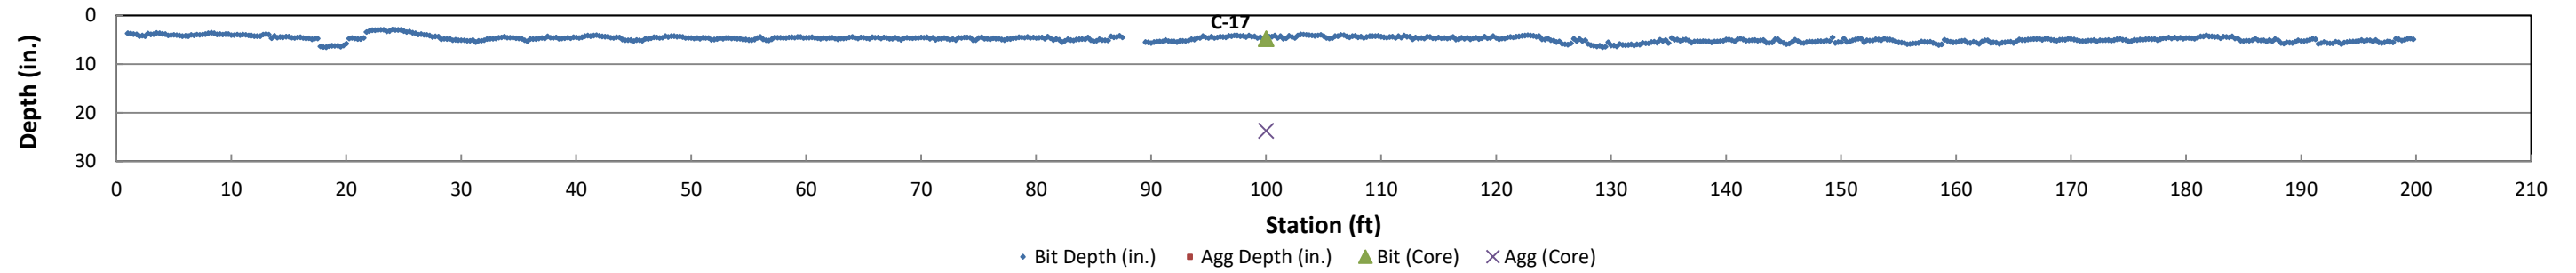
Jaguar Court (EB)

GPR Results: Jaguar Court - Jaguar Path to Cul-de-sac

Note: stations are positive in the NB or EB direction; SB or WB scans have been reversed

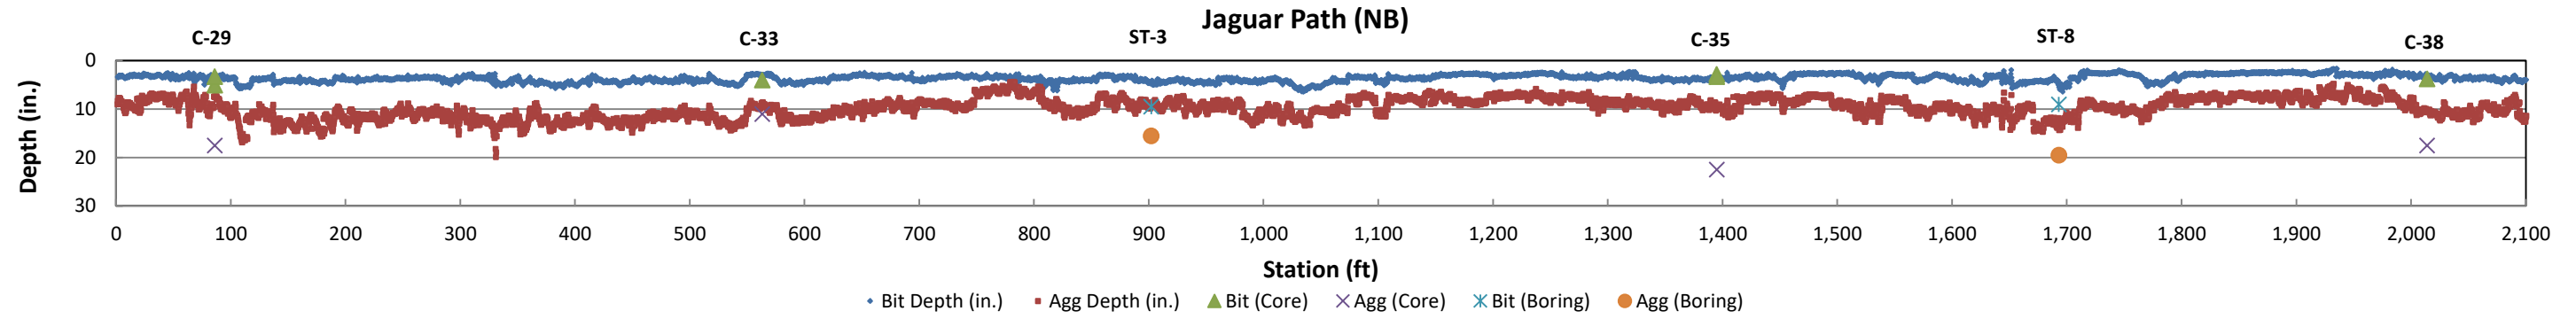
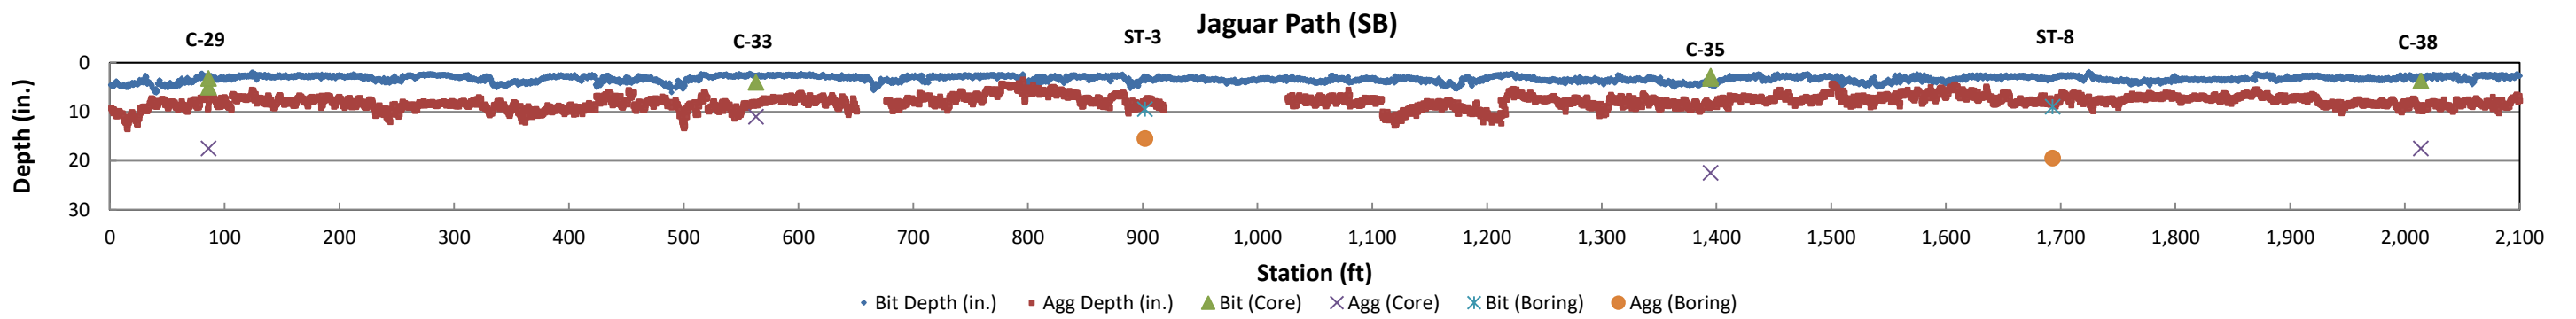
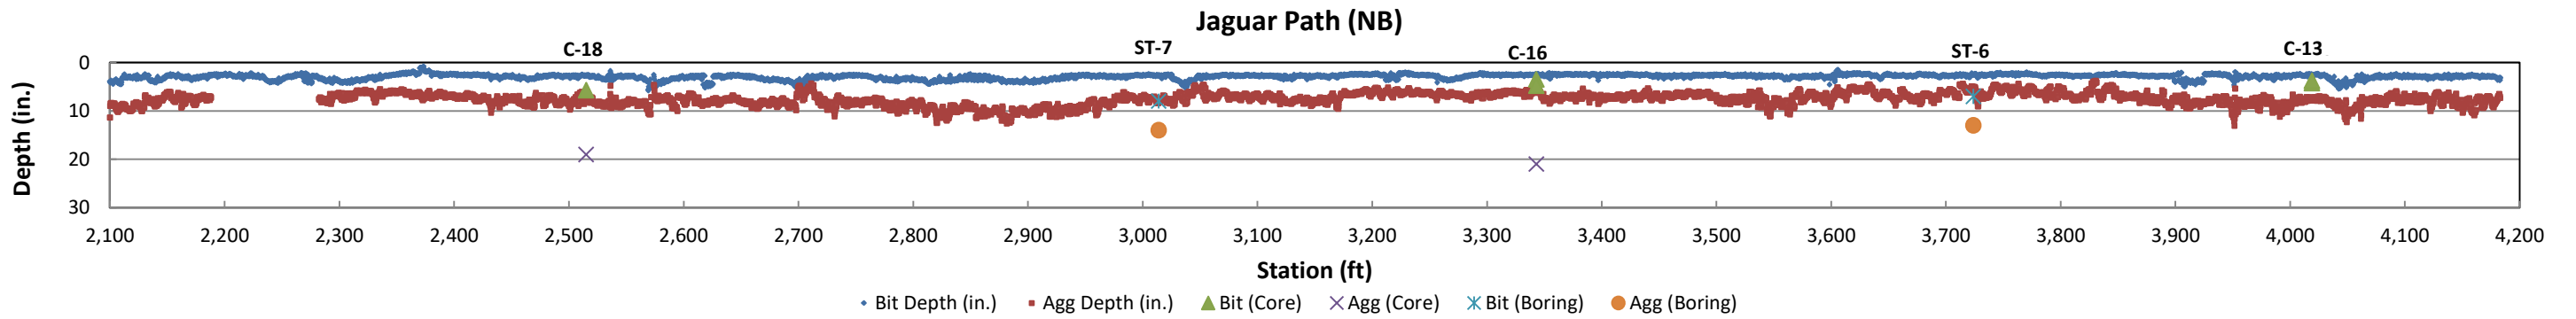
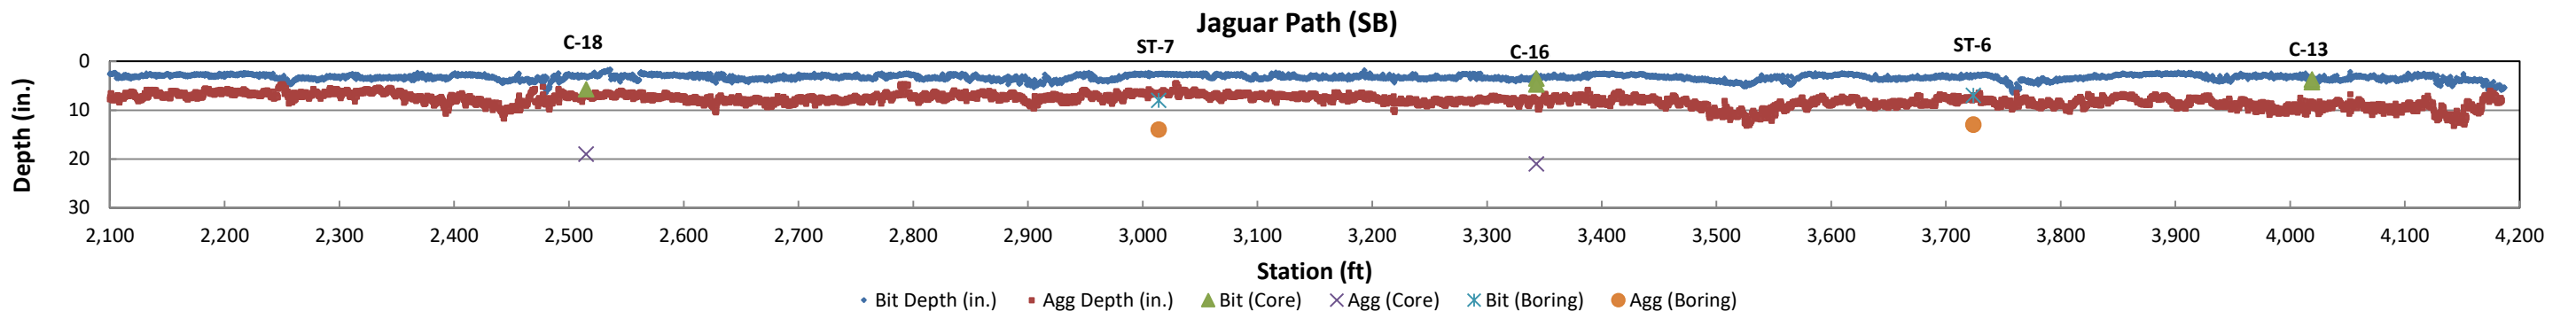
GPR Results: Jaguar Path - Upper 178th Street West to 175th Street West

Note: stations are positive in the NB or EB direction; SB or WB scans have been reversed

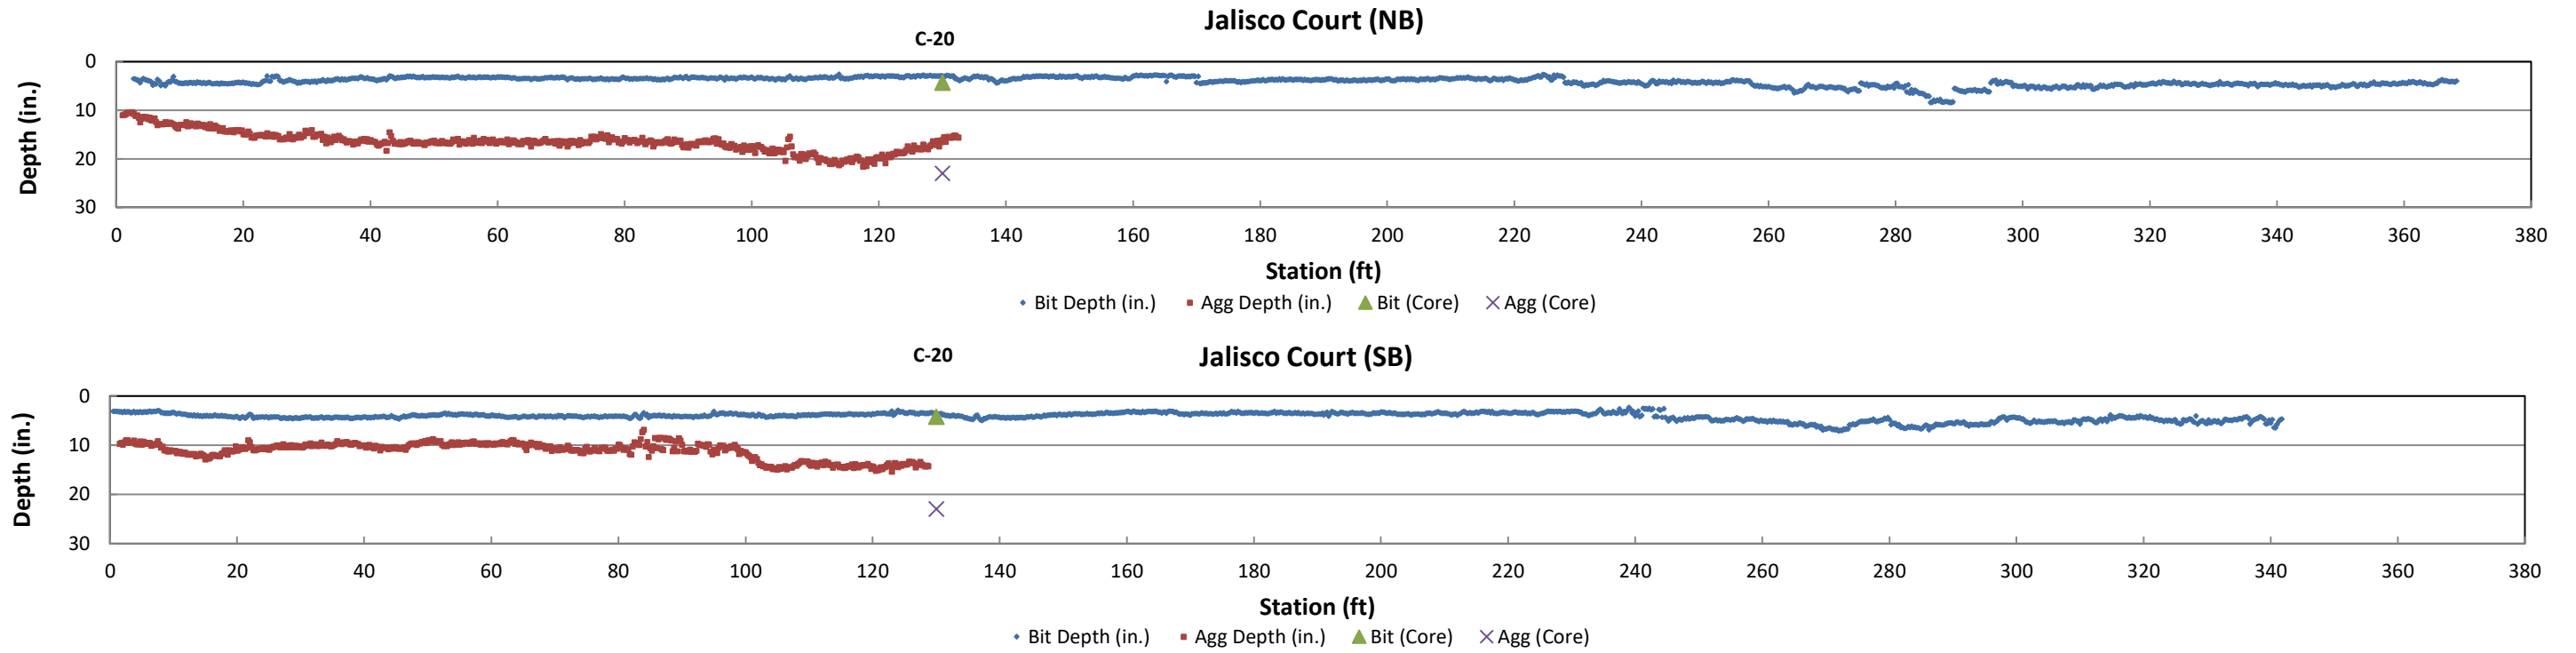
GPR Results: Jalisco Court - Jalisco Way to Cul-de-sac

Note: stations are positive in the NB or EB direction; SB or WB scans have been reversed

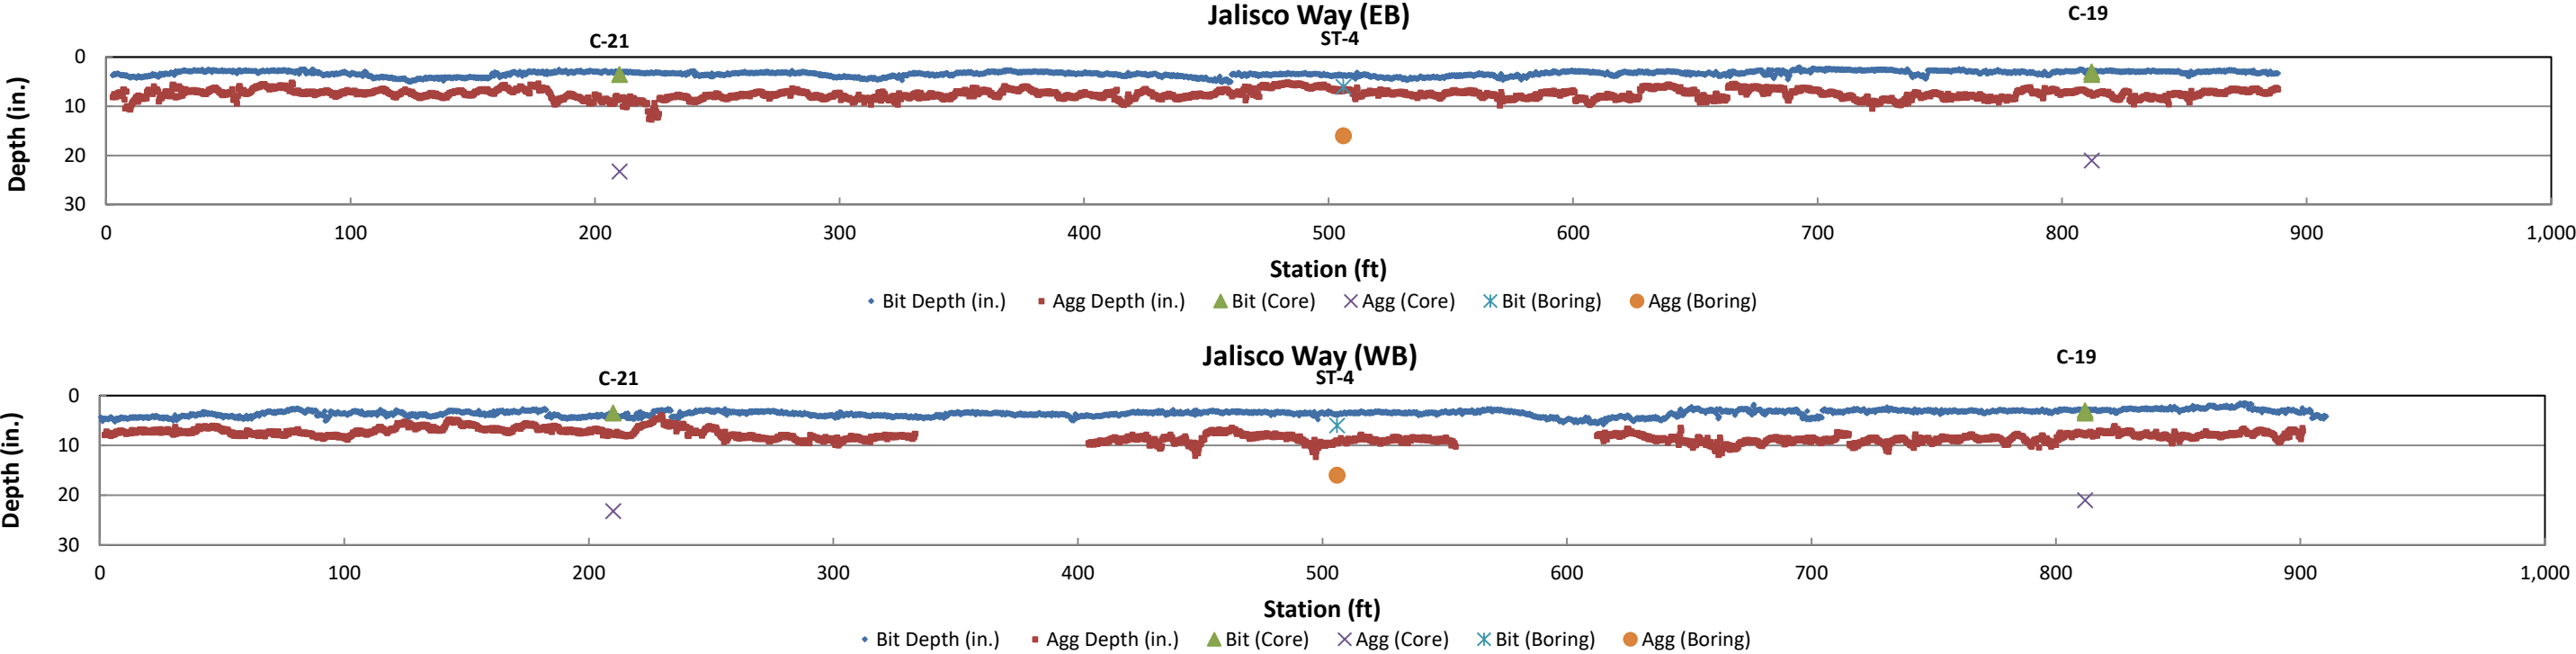
GPR Results: Jalisco Way - Upper 178th Street to Jaguar Path

Note: stations are positive in the NB or EB direction; SB or WB scans have been reversed

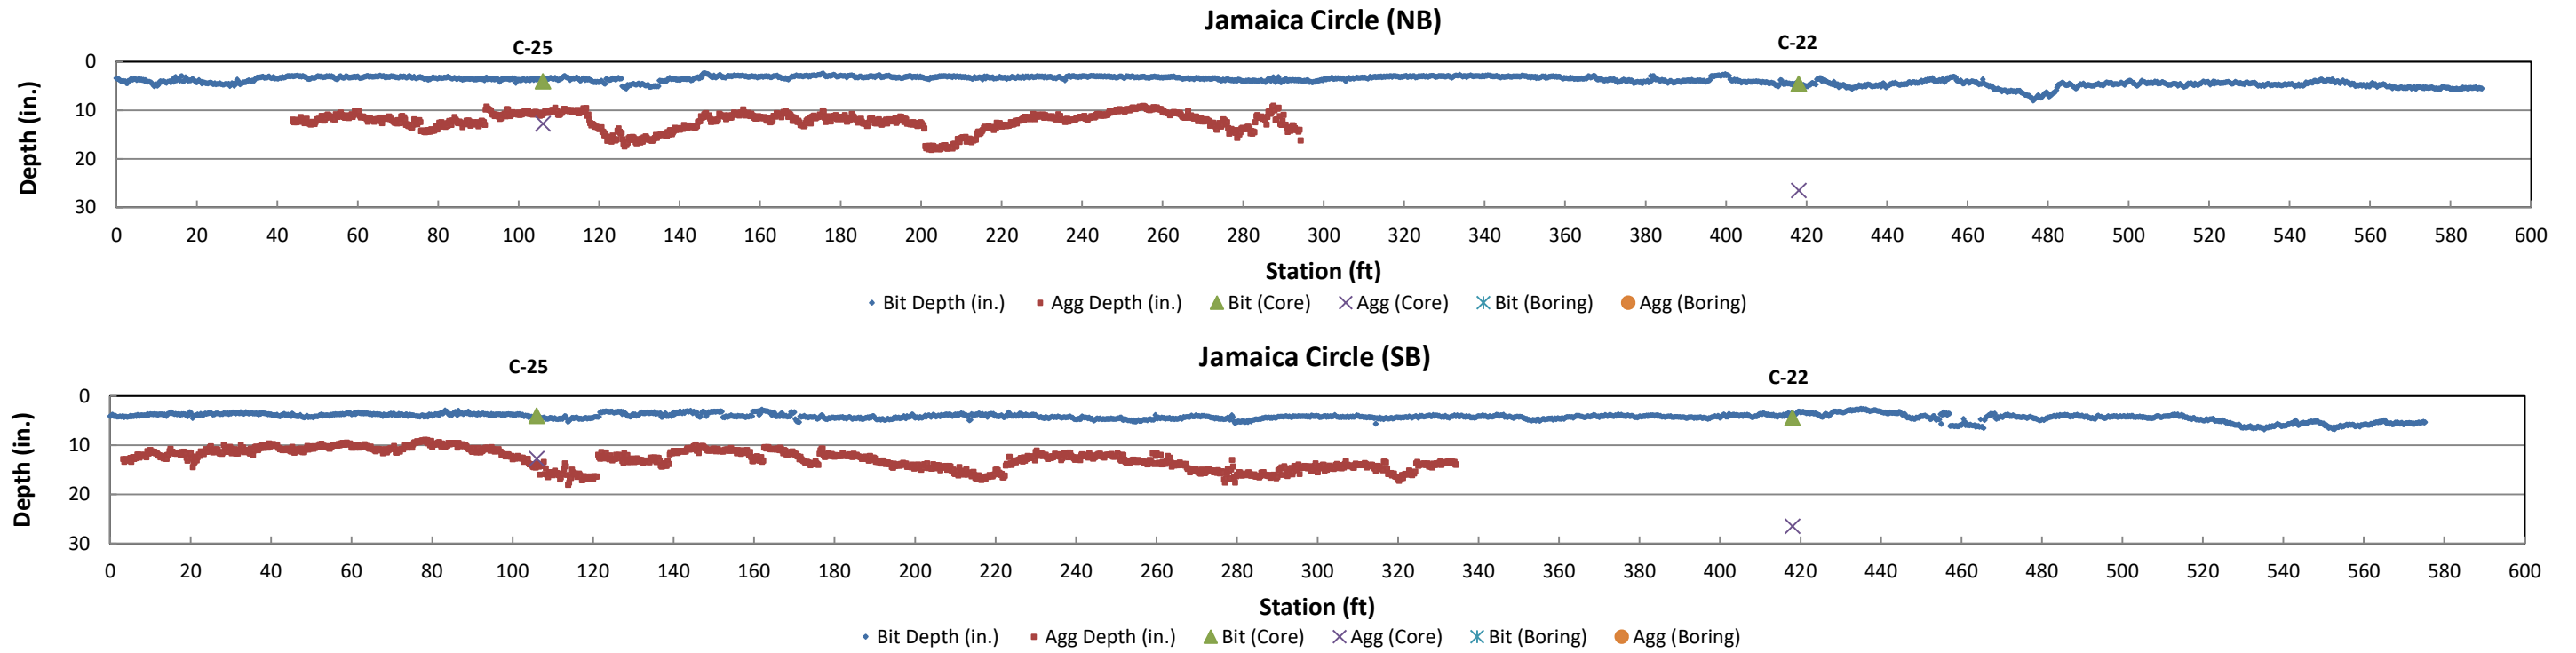
GPR Results: Jamaica Circle - Upper 178th Street to Cul-de-sac

Note: stations are positive in the NB or EB direction; SB or WB scans have been reversed

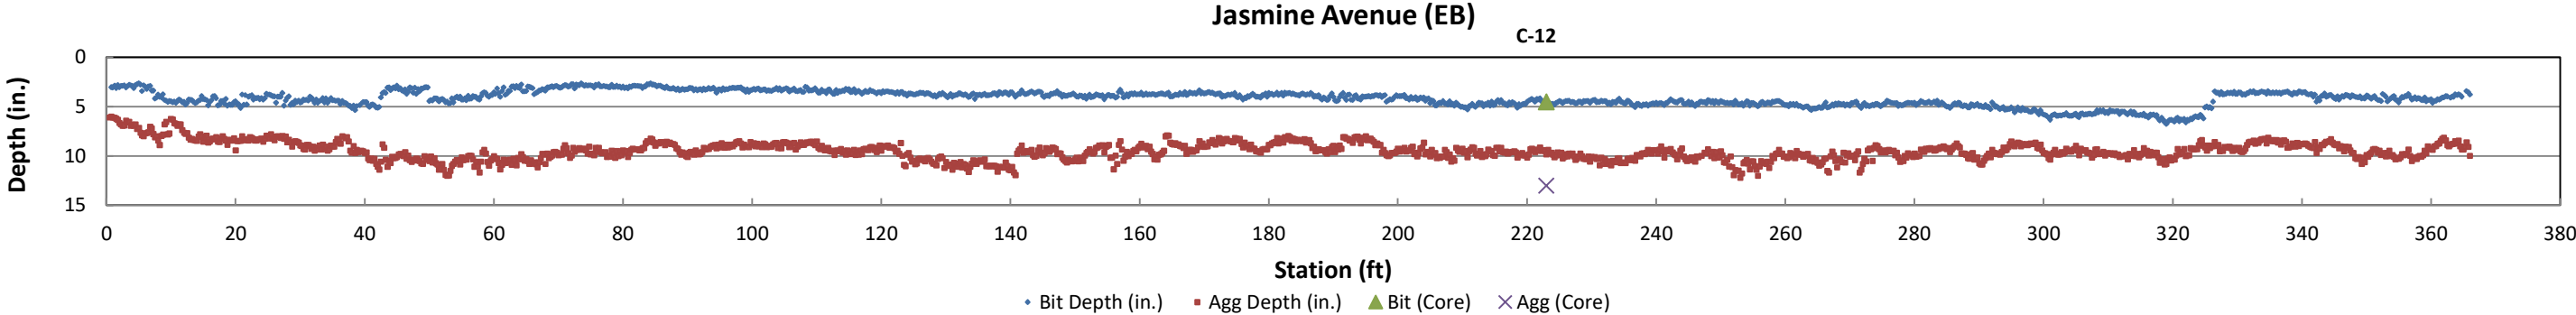
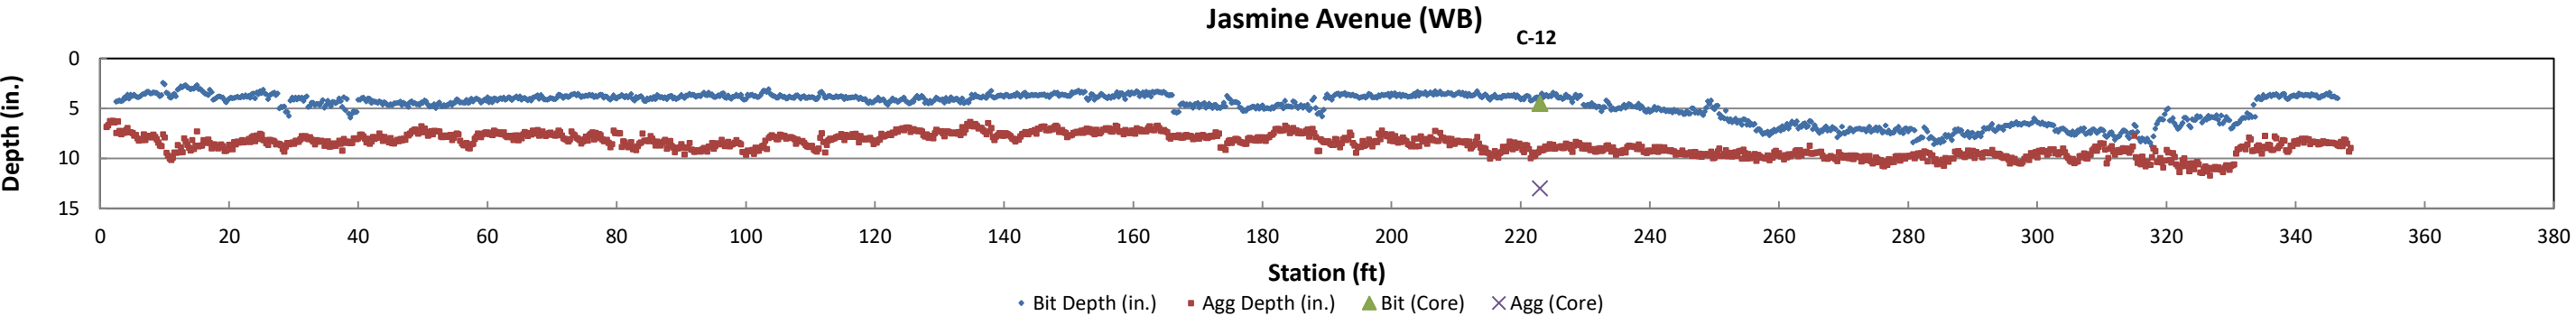
GPR Results: Jasmine Avenue - 175th Street West to Jaguar Path

Note: stations are positive in the NB or EB direction; SB or WB scans have been reversed
