ENGINEERING REPORT

2026 STREET REHABILITATION PROJECT

November 25, 2025

CITY PROJECT NO. 26-02

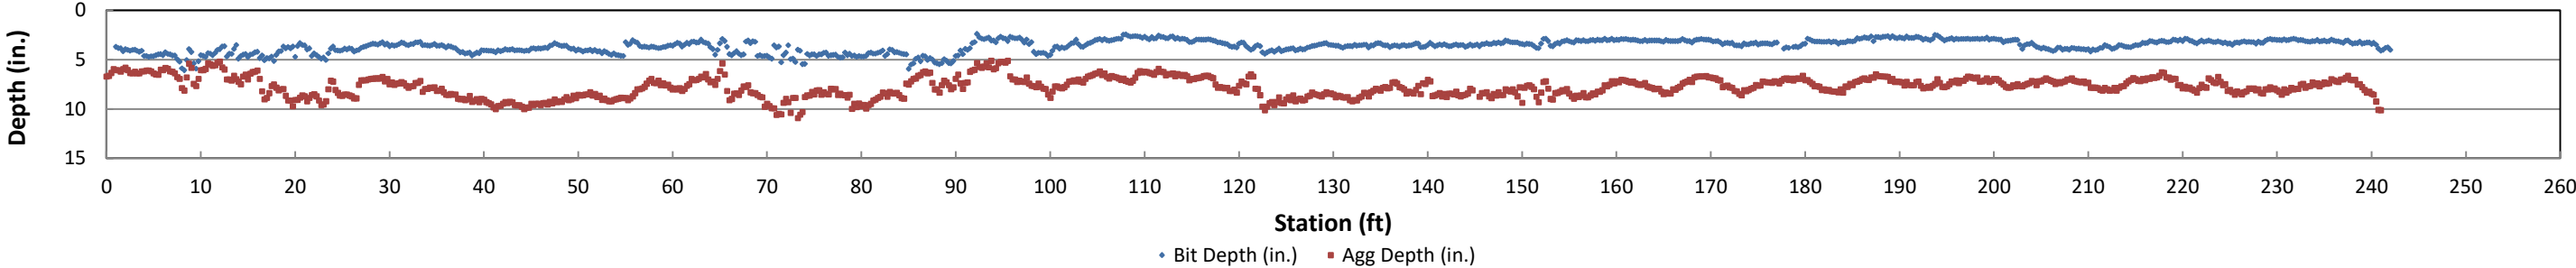
Jasmine Court (NB)

GPR Results: Jasmine Court - Jaguar Path to Cul-de-sac

Note: stations are positive in the NB or EB direction; SB or WB scans have been reversed

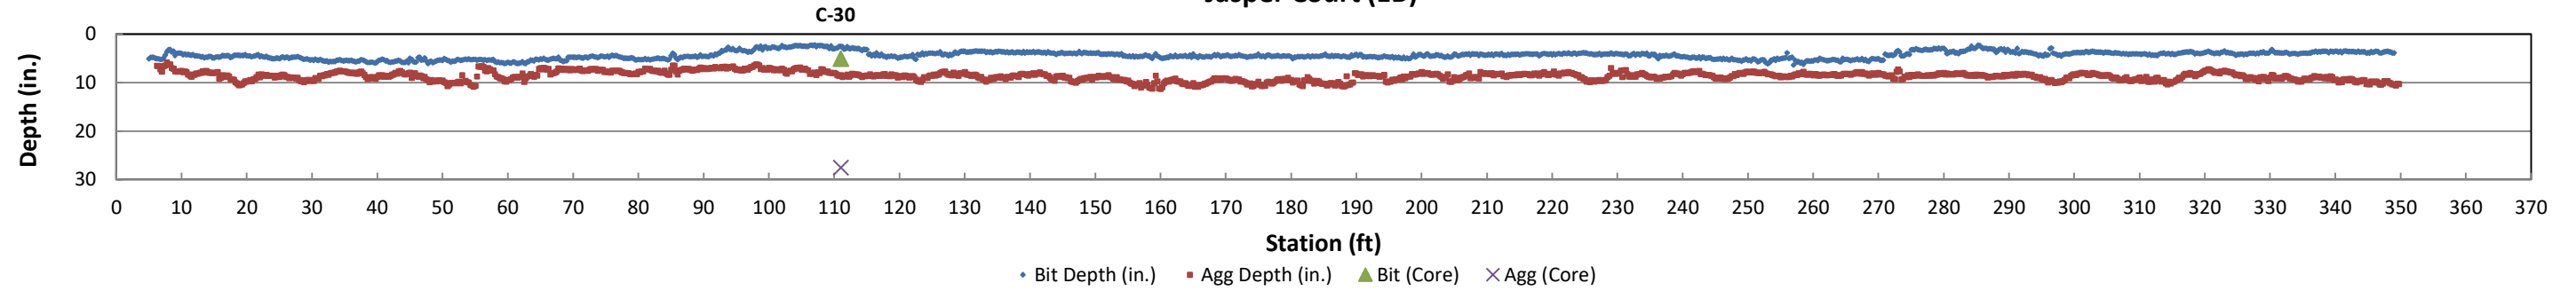
Jasper Court (EB)

GPR Results: Jasper Court - Cul-de-sac to Upper 178th Street

Note: stations are positive in the NB or EB direction; SB or WB scans have been reversed

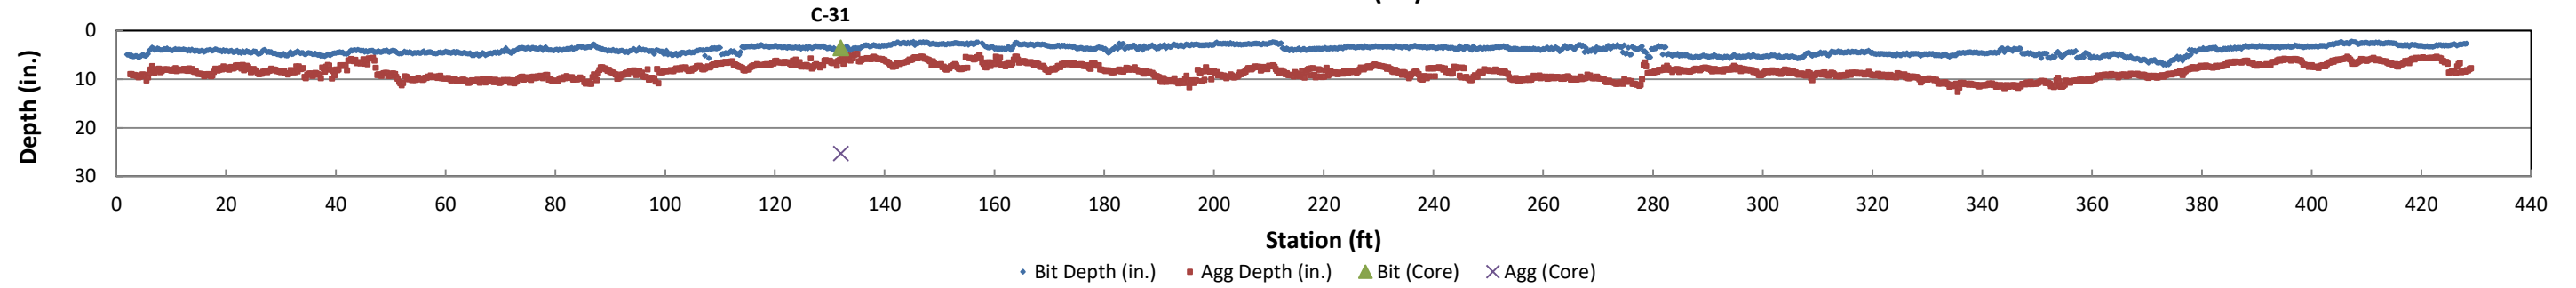
Javelin Court (EB)

GPR Results: Javelin Court - Cul-de-sac to Upper 178th Street

Note: stations are positive in the NB or EB direction; SB or WB scans have been reversed

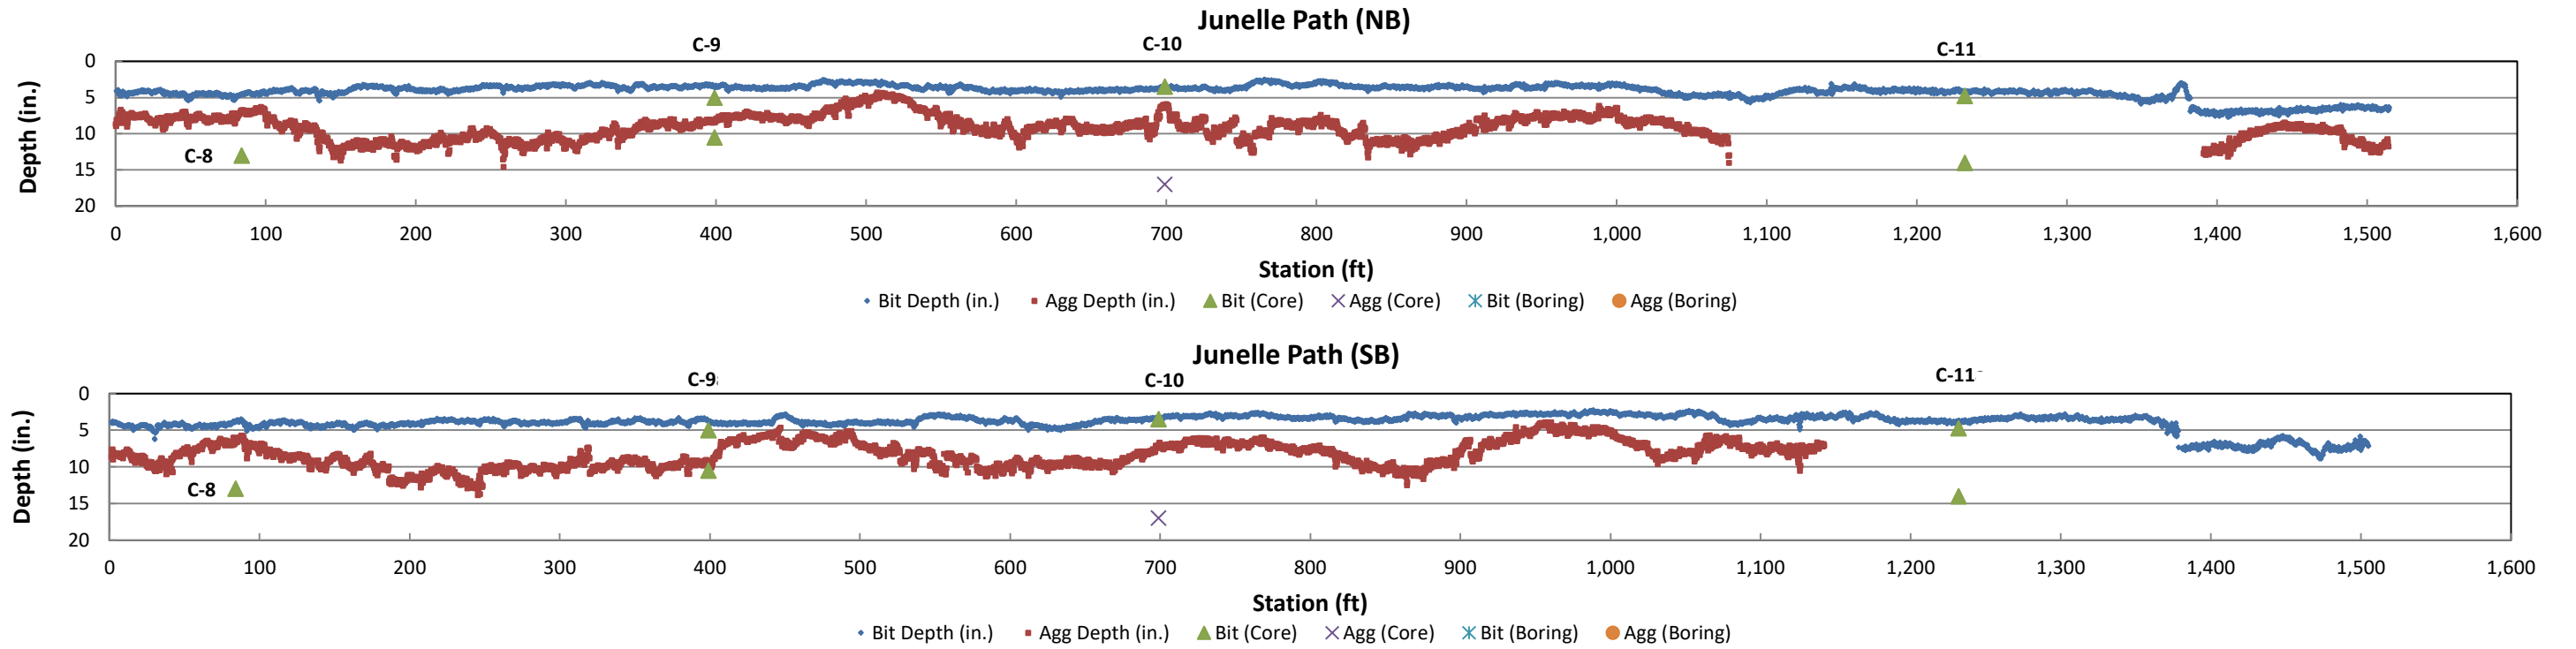
GPR Results: Junelle Path - Cul-de-sac to Kenrick Avenue

Note: stations are positive in the NB or EB direction; SB or WB scans have been reversed

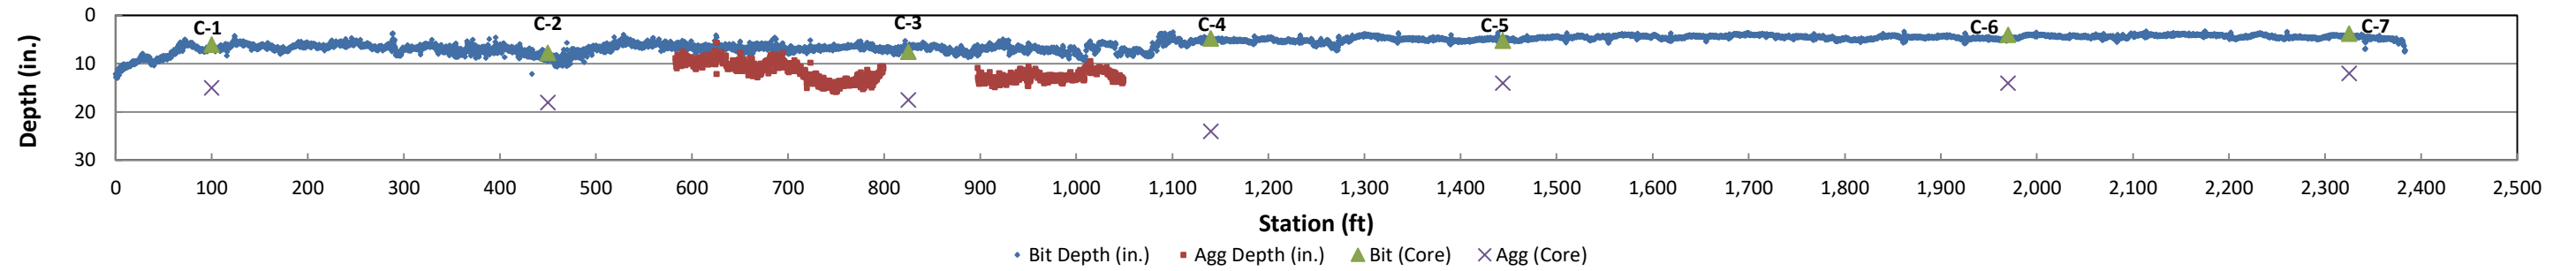
Kenrick Avenue (EB)

GPR Results: Kenrick Avenue - 185th Street West to 185th Street West

Note: stations are positive in the NB or EB direction; SB or WB scans have been reversed

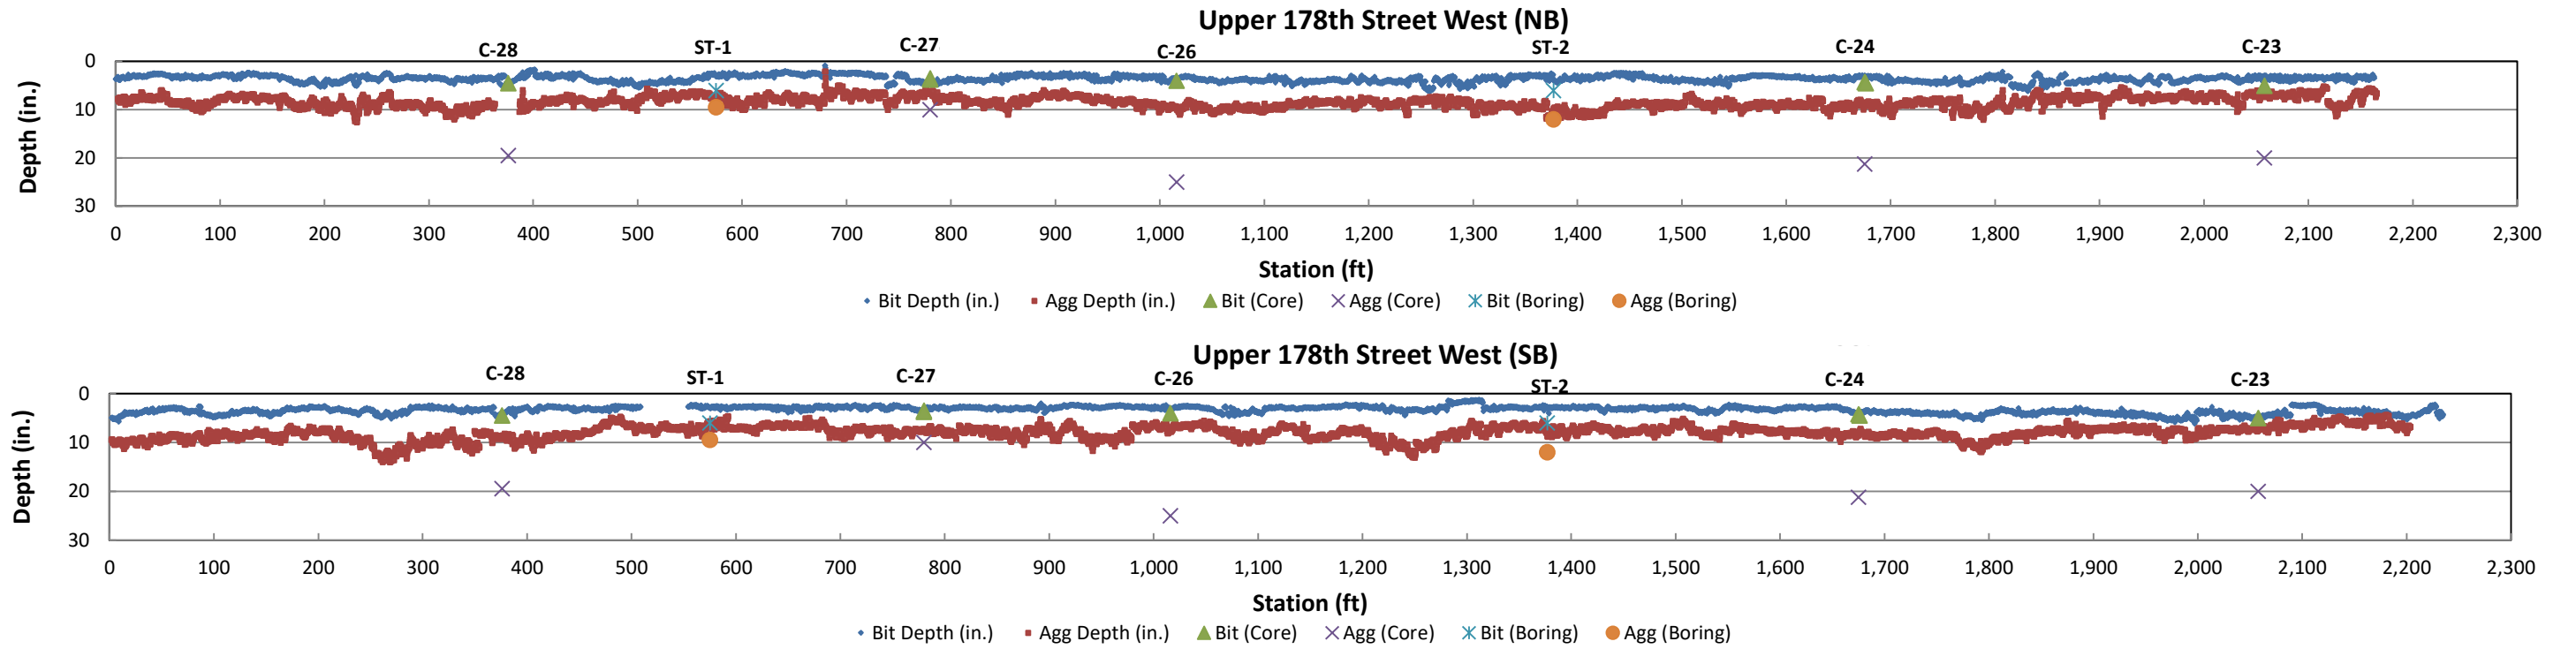
GPR Results: Upper 178th Street West - Jaguar Path to Jaguar Path

Note: stations are positive in the NB or EB direction; SB or WB scans have been reversed

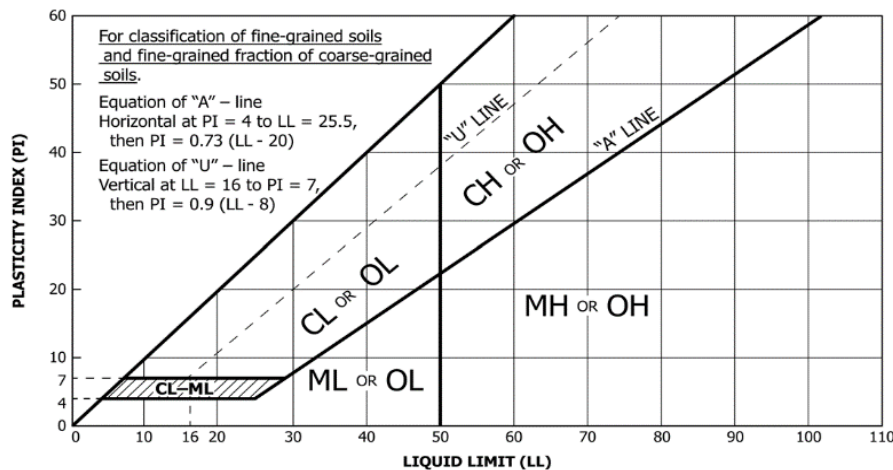
Criteria for Assigning Group Symbols and Group Names Using Laboratory Tests ^A				Soil Classification	
				Group Symbol	Group Name ^B
Coarse-grained Soils (more than 50% retained on No. 200 sieve)	Gravels (More than 50% of coarse fraction retained on No. 4 sieve)	Clean Gravels (Less than 5% fines ^C)	$C_u \geq 4$ and $1 \leq C_c \leq 3^D$	GW	Well-graded gravel ^E
		Gravels with Fines (More than 12% fines ^C)	$C_u < 4$ and/or ($C_c < 1$ or $C_c > 3$) ^D	GP	Poorly graded gravel ^E
			Fines classify as ML or MH	GM	Silty gravel ^{EFG}
	Sands (50% or more coarse fraction passes No. 4 sieve)	Clean Sands (Less than 5% fines ^H)	$C_u \geq 6$ and $1 \leq C_c \leq 3^D$	SW	Well-graded sand ^I
		Sands with Fines (More than 12% fines ^H)	$C_u < 6$ and/or ($C_c < 1$ or $C_c > 3$) ^D	SP	Poorly graded sand ^I
			Fines classify as ML or MH	SM	Silty sand ^{FGI}
Fine-grained Soils (50% or more passes the No. 200 sieve)	Silts and Clays (Liquid limit less than 50)	Inorganic	PI > 7 and plots on or above "A" line ^J	CL	Lean clay ^{KLM}

PI < 4 or plots below "A" line ^J	ML	Silt ^{KLM}
	Silts and Clays (Liquid limit 50 or more)	Organic	Liquid Limit – oven dried < 0.75 Liquid Limit – not dried < 0.75	OL	Organic clay ^{KLMN} Organic silt ^{KLMO}
		Inorganic	PI plots on or above "A" line	CH	Fat clay ^{KLM}
			PI plots below "A" line	MH	Elastic silt ^{KLM}
		Organic	Liquid Limit – oven dried < 0.75 Liquid Limit – not dried < 0.75	OH	Organic clay ^{KLMP} Organic silt ^{KLMQ}
Highly Organic Soils		Primarily organic matter, dark in color, and organic odor		PT	Peat
